The Thameslink Programme

Issue Date: 24th March 2016 - For further info contact sharon.fink@networkrail.co.uk

Issue Number: TLP052 Title: Loose Flashing

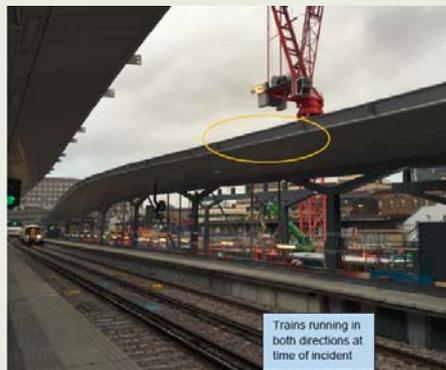
A section of the new canopy on platform 7 at London Bridge Station became partially detached in high winds. The nosing detail did not become fully detached from the canopy but was being moved significantly by the winds. It was assessed as presenting a risk to the safe operation of trains.

The immediate cause was that inadequate fixings on a section of the nosing to the platform canopy allowed the wind to get behind the nosing subsequently causing it to work free thus presenting a risk of failure and detachment and consequently presenting a risk to the operational railway.

Design: The design included the fixing detail for the permanent condition but not the temporary condition. This resulted in insufficient information being made available for the authors of the WPP, TBS and ITP.

Procedure: The WPP and associated TBS did not include the fixing detail for the nosing in its temporary condition nor in its permanent condition. The requirement for lining and levelling to achieve Costain CRE and Network Rail approval of sections of nosing [and therefore the need to not install all of the fixings] was also missing. This lack of detail resulted in no direction for those installing the nosing and consequently the nosing was installed without an adequate number of fixings.

- Design revised to include fixing detail (including temporary condition)
- WPP / TBS revised to include fixing detail / ITP revised
- Process to manage permanent works left in temporary condition being developed
- Governance of the Defect & Outstanding Work List (DOWL) system is being reviewed
- WPP / TBS / ITP being revised to make more prominent the requirements associated with the entering into service of works
