Shared Learning

COSTAIN
The Thameslink Programme

Issue Date: 11th April 2016 - For further info contact sharon.fink@networkrail.co.uk

Issue Number: TLP054 Title: Gate Detachment

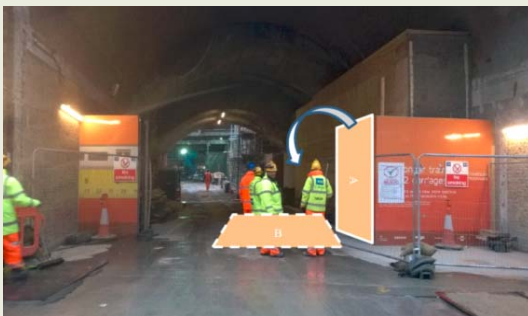
During nightshift works at London Bridge a vehicle access gate detached from the gate post and fell to the ground in an uncontrolled manner. The gate was in a fully opened position when it fell from position A to position B below. The gate that fell was made up of two sections and was 4m wide x 2.9m high with an approximate weight of 400kg. There had been a requirement to widen the gate and it had undergone a change to the original design.

Photo showing position of gate in normal position A and detached position B

Immediate Cause - The gate to gate post hinge fixing failed.

Design: There was a change in the original Temporary works design of the gate posts which originally specified that the gates were to be hung on square hollow section (SHS) 120mm (4mm thickness) steel posts and not the 80mm (3mm thickness) steel posts which were being used when the gate fell. There was a CAT1 design check certificate in place for the original installation. The original gate design detailed 2 No. gates of 2150mm width hung on 120 x 120 x 4mm steel posts. The Post wall failed and not the hinge. Tests will be done on the steel post and weld to establish the mechanical failure mode.

Design: The permit to load did identify the Post size changes and there was a hand written design change which stated the dimensions of the gate posts were now 80mm. This was agreed with the temporary works design team of these changes. There was no reference to the thickness of the steel which was originally 4mm and not 3mm thickness used on the modified gate post. The Temporary Works Supervisor & Co-ordinator signed off the permit to load and therefore approved the construction as fit for purpose (including any deviation & any additional work contributing).

Design: There is evidence of heavy 'wear & tear' of pin & ringbolt. There is a standard nylon wheel which was to be used to assist in opening / closing the by-fold gate. This was not specified on the original design.

Procedure: There was a failure to implement an inspection regime to check the gates on a weekly basis. The TWC stated on the permit that ongoing weekly inspections were required.

- Temporary works designs are now required to specify the details concerning the fabrication of the gate post of leafs
- Procurement process checked to make sure that CE marking and relevant BS EN is a requirement when plant / equipment is being purchased / hired in.
- Temporary works are to be inspected at all stages of construction and before loading.
