The Thameslink Programme

Issue Date: 12th June 2017 - For further info contact sharon.fink@networkrail.co.uk

Issue Number: TLP075 Title: Spanner Fell from Scaffold

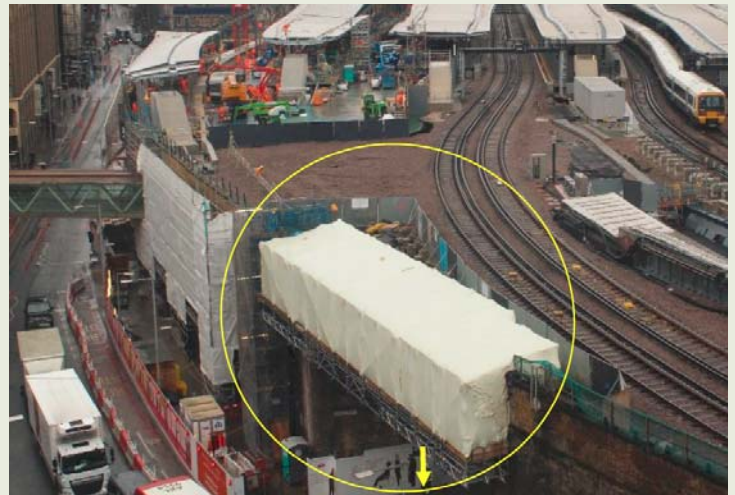
Encapsulated scaffold where spanner fell from

Immediate Cause: A spanner fell through a scaffold that did not have adequate protection to prevent falling objects.

- Design: Scaffolding was designed to carry out grit blasting & painting and not for repairs & strengthening works. This resulted in modifications [removal of plywood infills] that created the 'fall path'. The infills were not adequately detailed in the design drawing and when they were removed they were not properly refitted due to the design [foam seal broken].

- Design / Procedure: Failure by the Temporary Works Co-ordinator (TWC) and others, to identify that the scaffold had not been built in compliance with the design. The shrink wrap (Envirowrap) was not installed to the underside of the scaffold structure rendering the area below unprotected from falling objects once the plywood infills were removed.

- Procedure: The omission of a debris netting system to mitigate the risk of falling objects, and in particular where the plywood seals were removed, resulted in the loss of a barrier to the risk, namely inadequate falling object protection.

- All scaffold over public areas reviewed for netting / encapsulation.
- Process being developed for scaffold / changes to scaffolding to take account of lessons learnt from previous events.
- Engineers have undergone risk management training.
- Engineers have undergone an engagement session with regards to their safety responsibilities.
- WPP revised.
- WPP process rebriefed to the team including compliance to the process. This will also be reviewed at weekly WPP review meeting.
