Shared Learning

The Thameslink Programme Issue Date: 12th September 2017 - For further info contact sharon.fink@networkrail.co.uk

Issue Number: TLP079 Title: Dry Riser Failure

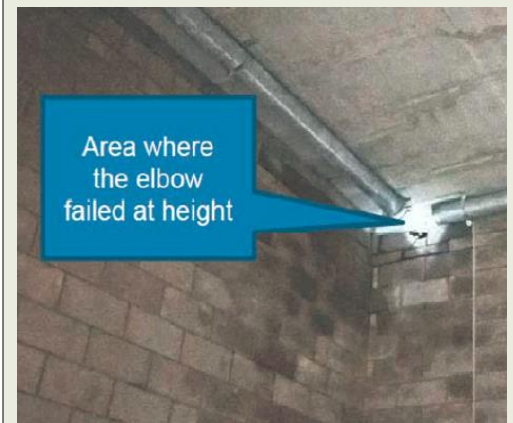
A 6 inch diameter dry riser was in the process of being hydraulically tested when it failed. The failure occurred at a 90 degree elbow which is approximately 5 metres from ground level. No one was injured. The failure occurred in an isolated room (SU 53) away from station operational and public areas. The event is being treated as significant due to the potential for injury to persons on site had the failure occurred at another point in the system.

Immediate Cause – The immediate cause of the incident was the mechanical failure, under hydraulic pressure testing conditions, of the Victaulic coupler on the dry riser main.

- Where a test or any procedure requires evidence of previous processes being undertaken, such as commissioning under an inspection and test plan (ITP), then testing will be carried out in accordance with the ITP and all witness signatures captured and ITP issued as part of the Information Pack (INP).

- Contractors to make sure WPPs and TBSs are strictly followed and all operatives involved have a clear understanding of the works by providing training to operatives on the installation and testing of Victaulic type systems.
