Shared Learning

The Thameslink Programme

Issue Date: 26th October 2017 - For further info contact mike.netherton@networkrail.co.uk

Issue Number: TLP081 Title: Mobile Tower Pole Came In Contact with an Energised Conductor Rail

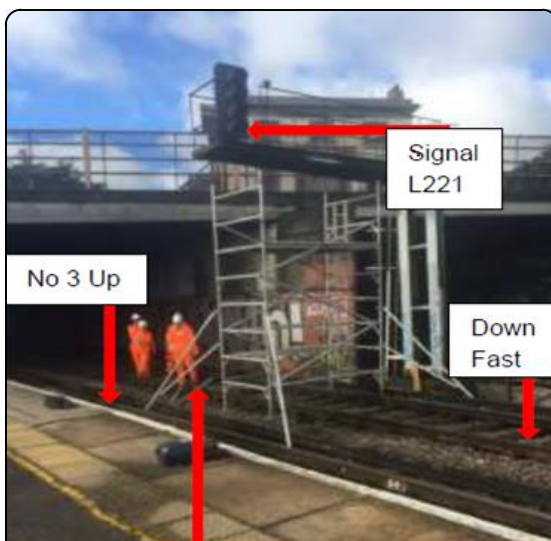
As the possession moved into Part 2, operatives were dismantling the scaffolding, after carrying out a survey, when a scaffold pole was dropped and came to rest between the No 3 Up Line conductor rail and the Down Fast running rail, causing a flashover.

Immediate – Work party were unaware an isolation had been lifted on an adjacent line and a metallic scaffold pole came into contact with a conductor and running rail causing a flashover.

Section of scaffold pole resting between the No 3 Up Conductor Rail and Down Charing Cross running rail.

- COSS's used on Thameslink to have competency formally assessed.
- Introduction of compliance checks at site level, when scaffolding is used and to confirm understanding of possession arrangements.
- Increased frequency of random D&A testing to deter substance abuse.
- Site Supervision to undergo competence checks related to tasks they supervise.
- Contractor to ensure adequate site presence of supervisors.
- ES/AP's briefing for multi-part possessions are to be clearly communicated to all COSS's and confirmation received that they have a full understanding of the safe work limits for each part of the possession.
- COSS's to stand-down work teams and re-brief any changed arrangements when moving between parts of possessions.
- Introduce process to ensure version control and legibility of SSOW packs.
