The Thameslink Programme

Issue Number: TLP082

Title: Flashover During Tandem Lifting Operation

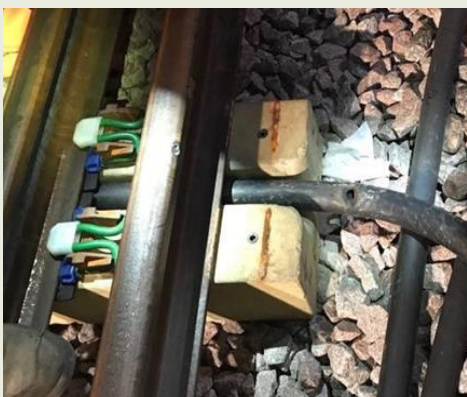
Photo of Event :

The loose rail which had been stored on the sleeper ends had vibrated onto the ballast and had compromised the sheathing of an energised traction cable sitting on the ballast.

Immediate Cause – Metallic object coming into contact with an energised conductor.

- The timely removal of redundant materials following completion of work.
- The sub-station DC circuit breaker had tripped several times over previous days, suggesting that there was a short circuit in the local area.
- As rail was stored on sleeper ends for a prolonged period, it appears that it vibrated off over a 52 hr possession due to vibration compounded by minimal ballast between the sleepers and the track not being bedded in.
- The Work Package Plan was written before new DC cables were energised and did not assess the risk associated with the DC or signal cables adequately.
- The Task Briefing Sheet and Lift Plan was generic and did not mention the use of a Road Rail Vehicle or specific details of the lifting arrangements.
- The removal of the rails had been planned on two prior occasions but due to delays and lack of planning for future works this had been curtailed.

- Review of the process around producing Lifting Plans.
- Implementation of enhanced audit checks for Task Briefing Sheet relevance/quality.
- Examine the protocol around sharing information between Network Rail and the project team on operational issues, such as electrical trips.
- Enhanced protection and controls around working in proximity to DC feeder cables, to be agreed briefed and implemented.
- Carry out first aid needs assessment to ascertain if the first aid provisions and training are suitable and sufficient for the work carried out.
