Shared Learning

The Thameslink Programme

Issue Number: TLP086

Title: Electrical Conduit Cut

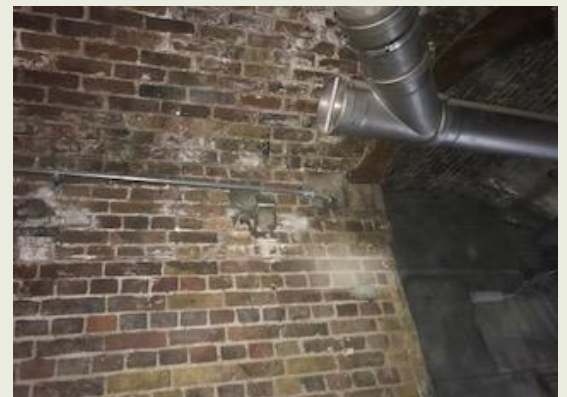
Whilst undertaking 'soft stripping' works, an operative cut through a live conduit using a reciprocating saw. The isolation certificate issued for the works had not taken into account a live conduit which had previously been installed above a false ceiling. The operative believing the conduit was part of the soft strip cut through it in preparation for removal.

The conduit was cut through during the day shift works and the operative did not realise he had cut through a live conduit. It is believed that the main distribution board tripped instantly. Later the same night, the external façade lighting failed to switch on. This highlighted there was an issue. It was at this point the on-site electrical nightshift team identified the damage.

Photo of electrical feed that was cut

Immediate - The cutting of a live electrical conduit with a reciprocating saw.

Error-proofing conditions: An Isolation Certificate had been completed, however, this document was substandard and did not detail the location of the live electrical conduit as part of permanent work.

Procedure: The project has worked to an informal procedure where all cut ends are orange ended requiring all to work away from the cut end. The Demolition Supervisor believed the cables routed in cable containment above the false ceiling were isolated and proceeded with the removal of conduit however the cables had no orange end markings on them.

- The orange end process has been documented and communicated to all project persons to include services that are cut and removed from the work area and where removal is not feasible then isolated services be clearly "orange ended" at sufficient locations such that the operatives undertaking the works can clearly see the service. If any live services remain live in the area they must be clearly marked and protected on site.

- The process for recording services – both 'as built' and 'as designed' will be improved. This will give up-to-date information and a simplified protocol of access to this information and will include a control on the permit to ensure location information is recorded.

- The revised isolation certificate now includes the requirement to undertake joint site visits to the area prior to any works. The permanent and temporary design drawings are to be reviewed and confirmed by the CRE for Fire Alarm, Electrical and Mechanical services representatives prior to work commencing.
