Lessons Learnt: Local & Formal Investigations

Date: 22nd September 2011

Issue Number: 005

Title: Thameslink Farringdon Project, Dislocated Shoulder

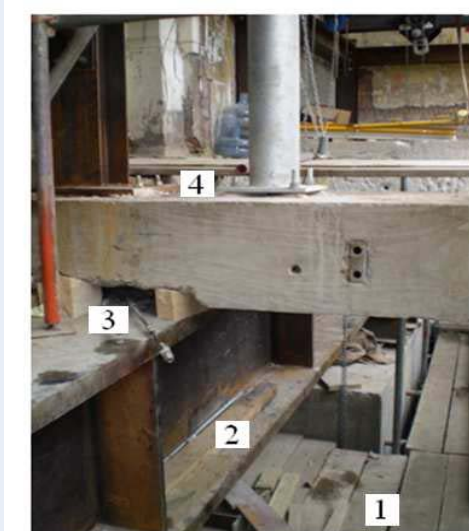
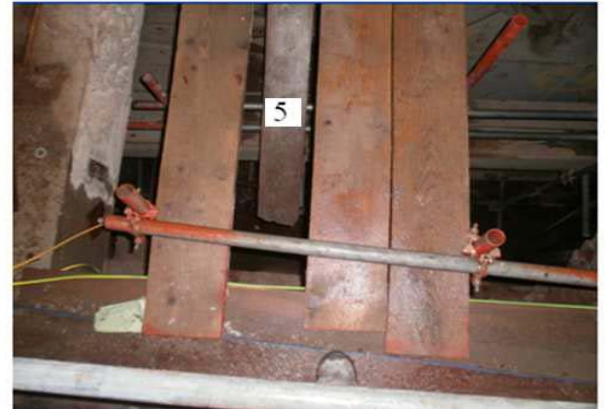
Numbers in the adjacent pictures show the walking route taken by the operative

The operative climbed from the scaffold where he had been working onto a steel beam, then a concrete beam and then a four board wide scaffold deck which gave way and from which he fell less than 2 metres.

The scaffold deck from which the operative fell had been created to guide a concrete pipe, it was not a working platform or pedestrian walking route

- The operative took a short cut and did not use the designated walking route as it was a quicker way to leave the work area
- The operative had been using the correct designated walking route previously
- Whilst the scaffold deck was not an access platform it had not been struck / dismantled after the concrete pump had been removed following the works.

Operatives should be reminded of official walking routes on sites.

All scaffolding not to be used for access should be barriered off and have appropriate signage.

Temporary scaffold decks must be removed when they are no longer required.
