No: IGS 243

Infrastructure Group Safety Bulletin

Inspection of OLE Catenary following insulator flashover

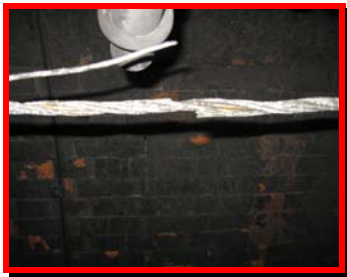
A recent incident occurred at Elstree Tunnel when staff who, after replacing a 'flashed over' insulator went to check the OLE Catenary; upon their approach the OLE Catenary parted in front of them causing a dewirement of the OLE. It appears that the OLE conductor had only one or two strands holding it, and the movement of the cantilever whilst the insulator was being changed added to the stress on the stranded wires resulting in the wire parting.

Figure 1: Stranded conductor

- That **prior** to checking and changing any OLE insulator that is part of the registration arrangement supporting a conductor, staff must follow the instructions contained in OLE Work Instruction NR/OLE B12 High level Catenary Intrusive Inspection.

- To inspect the catenary for parted or flattened strands, abnormal wear and corrosion arc erosion or burning at the following locations
 - At suspension clamps and within 1m of a suspension clamp paying particular attention to the hidden area of the conductor within the clamp itself;

- At pulley wheel suspension points and within 1m of the pulley wheel paying particular attention to the area of the conductor in contact with the pulley wheel.

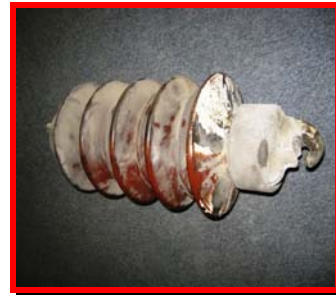
Figure 2: Flashover damage to top tube insulator
