No: IGS 259 (Issued 5th April 2012) - **UPDATE**

Infrastructure Group Safety Bulletin

GEISMAR THR542 STRESSING EQUIPMENT

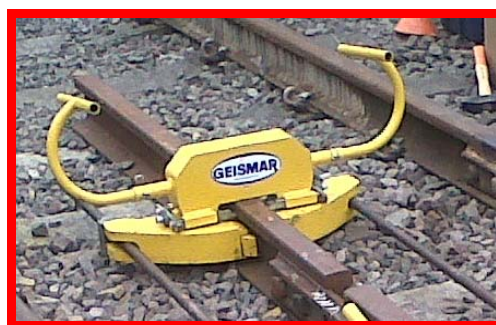
The equipment has in fact been suspended from use pending a full investigation into operational issues regarding the correct use of Geismar THR542 stressing equipment and a technical investigation into stressing equipment generally.

Geismar THR542 stressing equipment remains temporarily suspended from operational use on Network Rail Controlled infrastructure. All Geismar THR542 stressing equipment must remain in quarantine and be marked “**DO NOT USE**”.
