No: IGS 262

Infrastructure Group Safety Bulletin

GRP Scaffold Component Failure

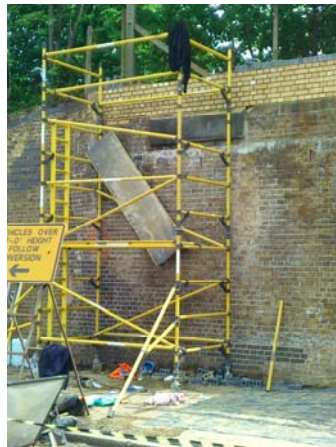
On Thursday 14th June 2012, two contractor operatives, undertaking brick repair work, were working off of a GRP tower at a height of approximately 4-5m, when the cross member that connects the platform, sheared. This caused the operatives to fall to the ground. Both received injuries as a result of this fall and were taken to hospital. It is anticipated that they will both make a full recovery.

This event is currently under investigation. At this stage the cause of the failure is unknown.

Network Rail reminds all Principal Contractors that they are required to have undertaken appropriate risk assessments when using scaffolding towers. However, in light of the incident involving the GRP tower, Network Rail reminds Principal Contractors using this type of tower that risk assessments include consideration of the following:

- a thorough inspection of GRP components by a competent person experienced in inspecting GRP scaffolds
- a review of the activities being undertaken from the GRP scaffold, to establish that the number of personnel, tools, materials and equipment, used on the working platform are within the safe working load of the platform and
- appropriate levels of site supervision
