No: IGS 264

Infrastructure Group Safety Bulletin

Lydney: Catastrophic Failure of Jacking Point on VMS Light Weight Signal Structure

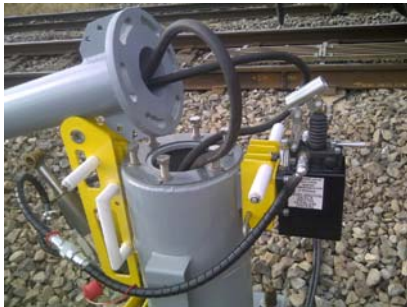
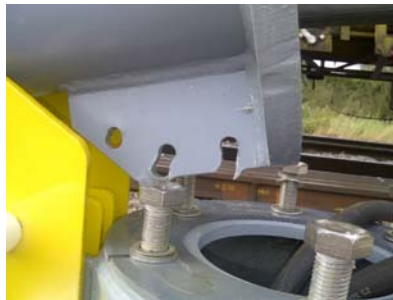
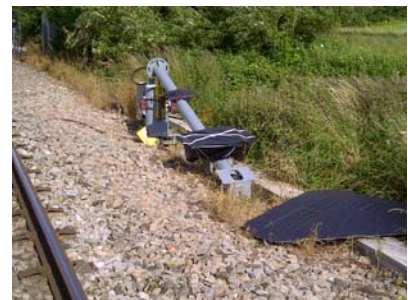
On 19th August 2012, a jacking point on a Variable Message Signs (VMS) Light Weight Signal catastrophically failed whilst being lowered to the ground. The light weight signal (NT1419) was being lowered during pre-commissioning works. No-one was injured as a result of this failure.

The cause of the failure is subject to investigation.

- Until such time as the investigation has concluded and the cause of the failure established, the use of the jack system is to be prohibited.
- If work is required to take place on VMS Light Weight signal structures, an alternative system of work is to be established.
