No: IGS 265

Infrastructure Group Safety Bulletin

Lifting Operation: Failure to Secure Loads. Borough Viaduct Project

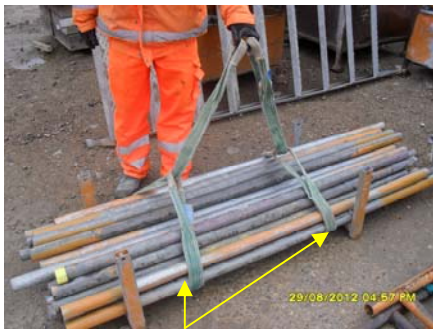
Load was secured with straps in between 2 unconnected scaffold storage frames

Weight of scaffold tubes
secures frame during lift

It was believed that the frame did not need to be secured to the load via the stop as it was held in place by the scaffold tubes.

The investigation established that it was practice (both on this and other Thameslink sites) to lift with the storage frames unsecured to the load. The diagram above right indicates how the frame remains stable under normal conditions, despite being unsecured. Subsequent enquires with both the onsite scaffold company and the supplier of the storage frame/stillage have clarified that this is not the correct methodology for lifting of this equipment, however this had not been documented prior to the incident, and the investigation indicates that this had not been effectively communicated to the operatives on this site (and it would seem to other sites also).

Those employees and contractors whose work activity involves planning or undertaking lifting activities involving scaffold tubes and storage frames, or related lifting brackets, on Network Rail sites are to review lifting activities involving this equipment to check that all component parts of the overall load are properly secured before lifting and specifically that the storage frame is secured to the load.

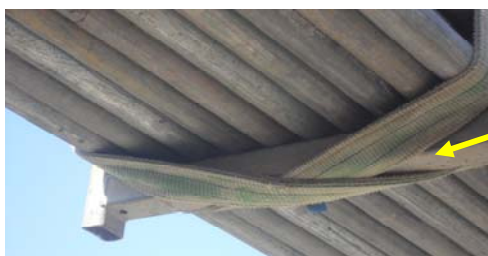
The frames at the site in question now employ a 'figure of 8' slinging technique around the frame/stillage and the tubes. This means that the stillage is tied in to the overall load and cannot become detached in the event of an impact – which should be the case for all lifts
