Network Rail
The Quadrant.
Elder Gate
Milton Keynes
MK1 9EN

No: IGS 265

Infrastructure Group Safety Bulletin

OLE Double Clevis ('808') in Tensioning Arrangements - Risk of Catastrophic Failure

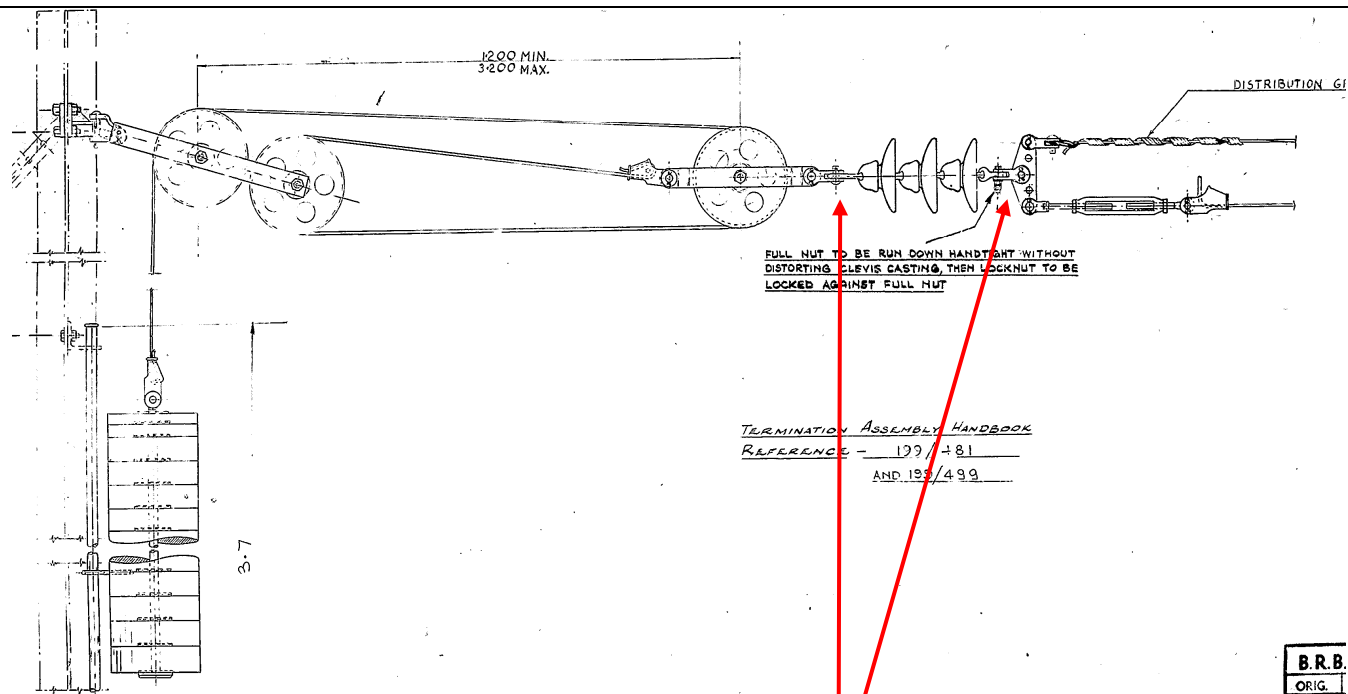
A number of double clevis ('808') components have failed recently in the line. An analysis of one of the failed fittings has concluded that it the fitting failed as a result of a manufacturing defect.

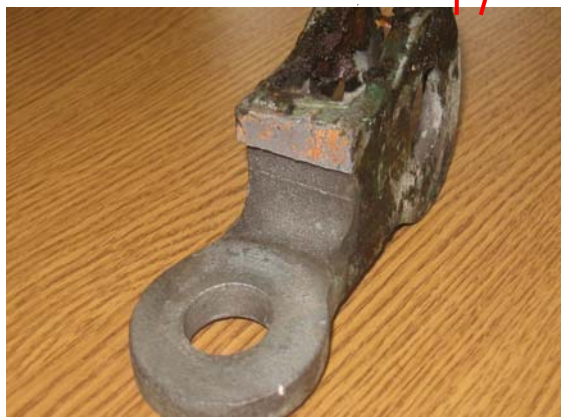
The arrangement that is at particular risk is in tensioning assemblies, where the double clevis connects an equalising plate to an insulator. The component is at risk of failure when carrying out work

Figure 2. –Double Clevis shown in balance weight arrangement

1. Brief all OLE staff of the risk of failure of the double clevis
2. Inspect the double clevis by using the camera on a pole and / or **as the first activity** during high level inspection. Any double clevis showing signs of cracking, fatigue or any opening of the clevis legs shall be replaced **before** carrying out any work on the wire run concerned.
