Date: Wednesday 11<sup>th</sup> June 2008

## Infrastructure Group Safety Bulletin 3350/174

## Unimog U400 MEWP Basket Failure.

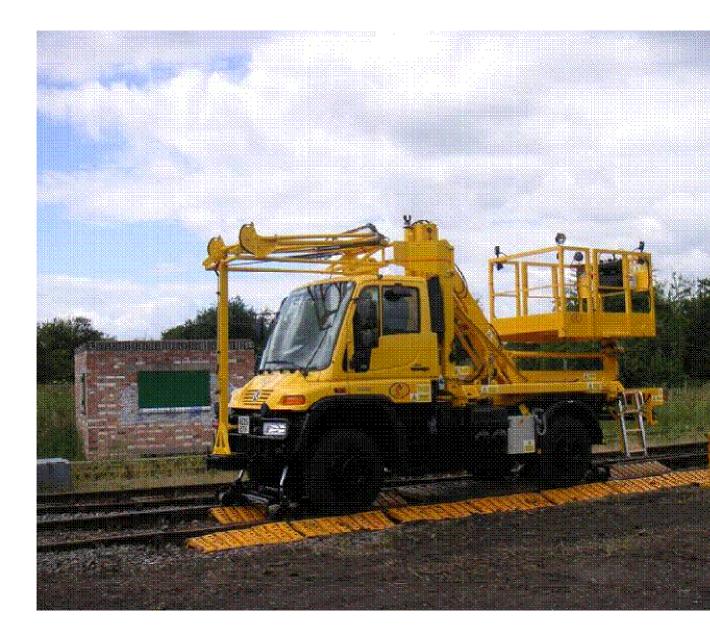
An incident occurred on 11<sup>th</sup> June 2008, at 1355, at Margaretting. Where 3 people were injured when the basket of a Network Rail Unimog U400 MEWP became detached from the boom. There is the possibility that overloading had occurred in the past and had caused damage to the basket to boom connection. The incident is under investigation by a team including the manufacturer but in the meantime all such machines must have visual inspection of the boom to basket bracket and if there are any signs of damage, including bending or cracking then the machine should not be used until a thorough inspection is carried out by a competent person. Further advice will be given when more information is available following the technical investigation.

A photograph of the machine is provided on the next page.
