27<sup>th</sup> July 2009

No: IGS 201

# **Infrastructure Group Safety Bulletin**

## **Track Buckles**

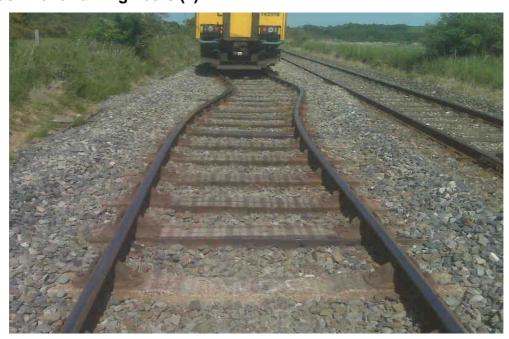
Readers are reminded that a number of factors may contribute to track buckles on the network. The following features in particular are brought to your attention:
