No: ISG 229

Infrastructure Group Safety Bulletin

Hot Axlebox Detector Wrong Side Failure caused by Track Maintenance/Renewal Activity

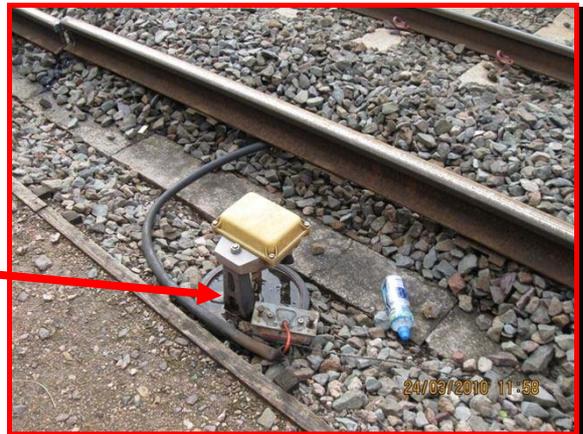
Background: Whilst downloading data from a GE FUES Hot Axlebox Detector recently it was noticed that the HABD had not been recording trains for several weeks. The signalman's monitoring screen confirmed this but indicated that the HABD status was 'OK' and no faults were displayed. A site investigation found the HABD wheel sensors had been unbolted from the track, the rail had been replaced but the wheel sensors had not been refitted. The electrical integrity of the HABD system had not been compromised but it was unable to recognise approaching trains. This constitutes a wrong side failure of a safety critical system.

This HABD wheel sensor was unbolted from the rail and left lying on the ballast;
It is critical that equipment is checked, reconnected or re-fitted when work has been completed.

1. Before carrying out any Track Maintenance or Track Renewal activity, staff must assess the site and note any equipment installed on or attached to the track which may be affected by the work.
2. The function responsible for the maintenance of the equipment identified must be contacted and arrangements made for the equipment to be disconnected or removed before commencing work on the track and re-connected or refitted when the track work has been completed.
