No: ISG 240

Infrastructure Group Safety Bulletin

Vegetation flailing operations

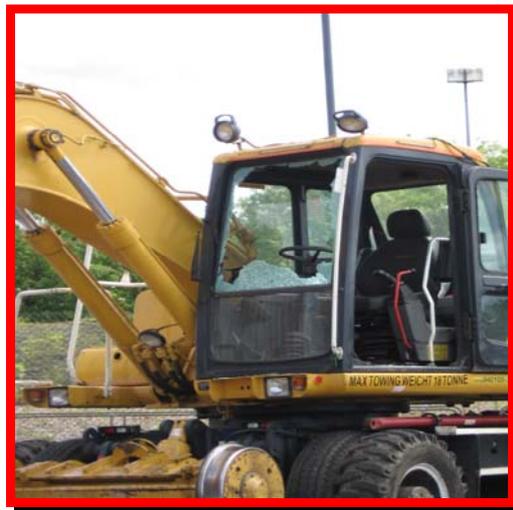
A recent incident occurred during the use of a flailing attachment on a Road Rail Vehicle (RRV). The operator suffered minor eye injuries when during operation, the flail struck an object believed to be a pandrol clip in the undergrowth and propelled it towards the cab of the excavator. The clip struck and smashed the glass windscreen resulting in the operator being hit with shards of glass

- When supplying an RRV with flailing attachment, the RRV shall be fitted with an appropriate windscreen guard or other suitable means of windscreen protection.
- Flailing mowers shall be fitted with suitable guarding appropriate for the type of flailing operation being undertaken.

IMDM's and line managers, Project Managers or work delivery managers are reminded that a site survey must be completed prior to the commencement of operation. Action must be taken to remove all identified hazards if practicable or Machine Controllers and Operators must be briefed on any additional risk mitigation measures.

- To wear hand, eye and ear protection
- To maintain a 100m exclusion zone from the flail head
- Remove debris from roads, public areas and S&C, and excess debris from the infrastructure.
