No: IGS 250

Infrastructure Group Safety Bulletin

Croydon DU – Track worker struck by train

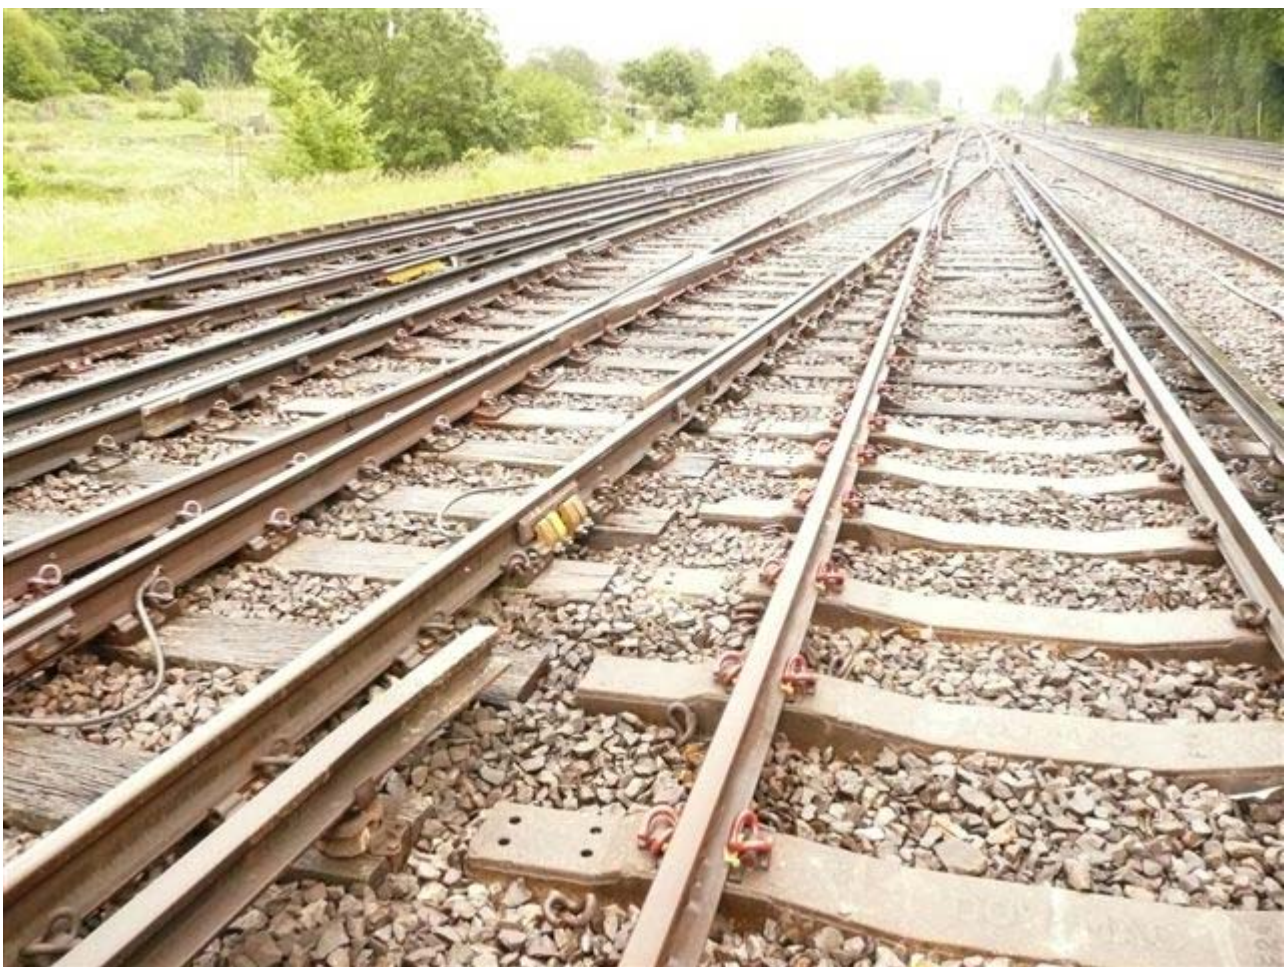
The below diagrams show the layout of the site and the location of the accident. At this stage in our investigations it is not possible to state the cause(s) however; the immediate investigation is centered on the activities being performed, proximity of the adjacent Up Redhill line that had earlier been re-opened to traffic and the planned and actual methods of protecting staff from movements on the adjacent line

- All employees who work on and around the track are to be briefed on the circumstances surrounding this accident before commencing their next shift.
- During the briefing employees should be reminded of the need to be vigilant when on and around the track and to know their position of safety at all times
