No: IGS 251

Infrastructure Group Safety Bulletin Reading DU – Track worker Near Miss at Westbourne Park

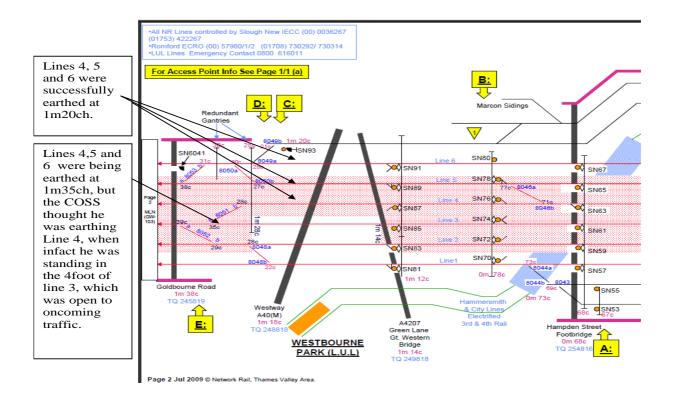
The COSS successfully applied earths to Lines 4 and 5 and then stood in the four foot of Line 3 and attached the earth to the OHL which resulted in an electrical flash. The track worker assistant who was standing in the four foot of Line 4 saw a train approaching the COSS on Line 3 and he shouted to the COSS to clear the line. The COSS jumped to a position of safety, but left the fibre glass isolation pole in situ, which was struck by the train. It was the train striking the pole, which made the train driver mistakenly; believe he had struck a person.

Upon initial investigations, it appears the COSS was mistaken when he was applying the earths. The COSS says he had worked in the general vicinity on the previous Saturday, but had not worked at this location before. It is reported that a site visit had not been carried out prior to the COSS attending site to apply the earths this weekend. The lines are numbered up in the signalling gantries. The COSS had been briefed by ES. The COSS had been issued earthing details from the Nominated Person

- All employees who work on and around the track are to be briefed on the circumstances surrounding this accident before commencing their next shift.
- During the briefing employees should be reminded of the need to be vigilant when on and around the track and to know their position of safety at all times
