No: IGSB 254

Infrastructure Group Safety Bulletin

Common factors in Isolation Incidents

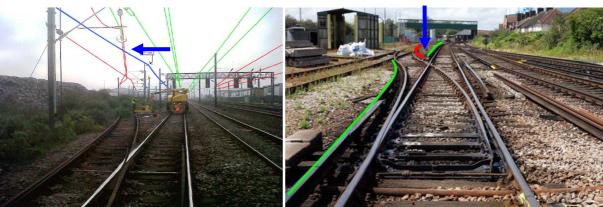
Although occurring on lines equipped with different electric traction supply systems, both incidents occurred at locations where connections from sidings joined the main line. Photographs of the locations are included below. In each case the isolated equipment is shown in green, with the live equipment shown in red. The blue arrows indicate the points at which the accidents occurred.

Figure 1: Hendon

Figure 2: Littlehampton

The incident at Hendon occurred when the installer of an Autotransformer Feed (shown in blue on photo) came into close proximity with live OLE leading to the siding.

At Littlehampton staff commenced work on a section of live conductor rail in the mistaken belief that it had been isolated; flashover of traction current occurred when a piece of equipment came into contact with adjacent sections of live and isolated conductor rail, causing a short circuit. In both cases the permit to work* correctly showed that only the main lines were isolated.

Engineers, Project Managers, Line Managers and planning staff are reminded that, during the work planning stage, a full assessment of electrical risk must be undertaken in accordance with relevant instructions for working on electrified lines (AC lines – NR/SP/ELP/29987, modules 2 & 3; DC lines – NR/WI/ELP/3091). This assessment should include a site visit to all areas to check equipment configuration, feeding points, points of isolation and earthing/strapping points. Particular attention should be given to connections to/from sidings or adjacent lines, feeder stations, aerial busbars, live switches/terminals/equipment, etc.

Whenever work is to be added or amended at a late stage during the planning process, after the isolation has been planned, the <u>Nominated Person (AC)/Isolation Planner (DC)</u> must check that the isolation remains suitable for the work being carried out.

<u>The COSS</u> who receives the permit to work must include full details of the safe working limits of the isolation in his safe system of work briefing. It is the duty of the COSS to ensure that all persons in the workgroup are aware of, <u>and fully understand</u>, the safe working limits.

Extreme care must be exercised if tasks are added or changed during the course of the work. Whenever this occurs, the COSS must refer to the permit to work to verify that the safe working limits will not be exceeded. If this is not sufficiently clear, the COSS must seek advice from the person who issued the permit to work.

<u>Employees</u> working on or adjacent to electrified lines must <u>NEVER</u> assume that an isolation is identical to one previously granted, even if the activity is a continuation or repeat of previous work. The activity must always be governed by the safe working limits shown on the permit to work. <u>Every isolation must be considered to be unique</u>.
