No: IGS 211

Infrastructure Group Safety Bulletin

PELI Battery Operated Portable Lighting units, Models 9460 Twin-Light Model & 9470 Four-Light Model

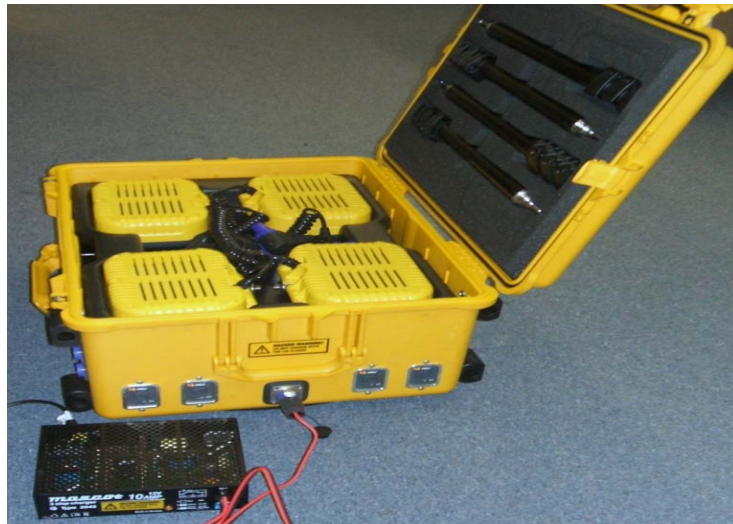
On 9th September 2009, severe damage occurred to a PELI lighting unit whilst being recharged. The damage was caused by a faulty component causing an over voltage to be supplied to the battery. Further tests have concluded that this component failure is very unlikely to occur again. However the unit did appear to have been subject to some overheating which may have been a contributing factor to the failure.

1. Operators should ensure that when the PELI units are on charge the lid is left slightly open as detailed in the operating instructions as the closed lid does not allow heat or vapour to escape.
