No: NRS 264 – ISSUE 2

Network Rail Safety Bulletin

Re-introduction of VMS Hydraulic Lifting Device

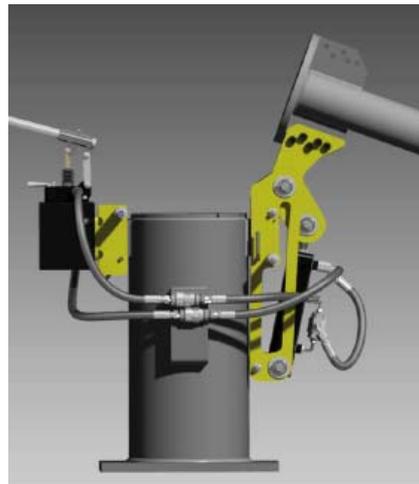
Figure 5

- Figure 5, shows the 5 hole arrangement in the HLD.

1. Inspect the condition of the datum arm: fillet welds and existing holes before commencing with either modifying or attaching the lifting device to the signal post.
2. When undertaking this modification ensure that the procedure detailed with in 'OM_001588_REV I_Installation manual' and 'SI-000092 Rev A' are followed.

Action required: All existing Hydraulic Lifting Devices (HLD) must be modified to the 5 hole arrangement before re-introducing into operational use.
