No: NRS 273

Network Rail Safety Bulletin

Embankment Stability: Action to be taken at times of Adverse Weather/Flooding

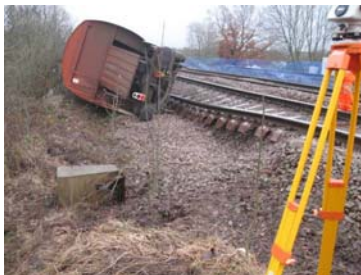
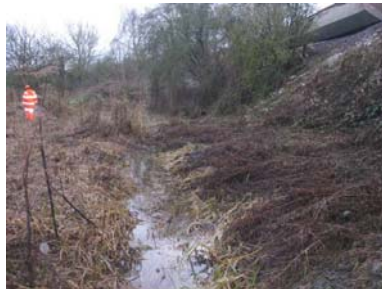
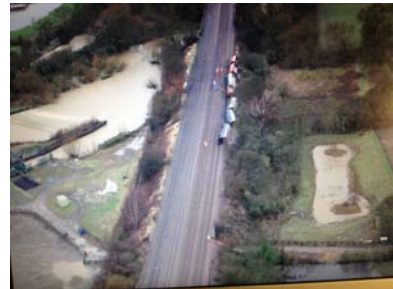
A freight train derailed on the 27th December 2012 at Barrow-Upon-Soar in East Midlands. Whilst the matter remains subject to formal investigation, initial reports indicate that the derailment has been caused by a short length of embankment failing and the cess rail subsiding.

The embankment is adjacent to the River Soar and both sides had been retaining standing water in recent days.

Staff are asked to notify the Route Civils/Geotechnical Teams to request a special examination of the embankment if:

The land at the bottom of embankment is flooded or has been recently flooded

and any of the following have occurred:

1. A rough ride is reported on the embankment
2. Reactive track maintenance works, related to geometry, top or alignment faults, have been recently undertaken or are planned on the embankment
3. Loss of ballast in the shoulder, cess or between sleepers is observed
