**No: NRS 287 Issue 2**

## **Network Rail Safety Bulletin** **Return to Service – Genie Z-135 MEWPs**

**This bulletin supersedes NRS 287 issued on 20<sup>th</sup> June 2013**

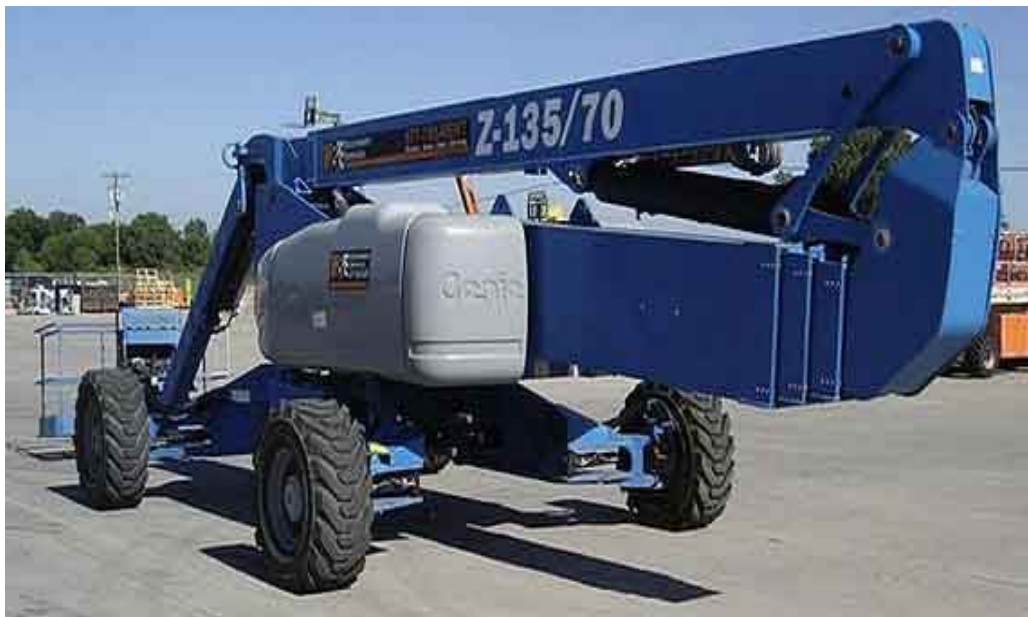
This incident was investigated by HSE who found that the root cause was an incorrectly calibrated secondary boom. HSE also found that, if followed correctly, the manufacturer's process for calibrating this machine is robust.

Genie have pro-actively updated the software for this machine. This updated software includes additional checks to the secondary lift calibration procedure without altering the physical calibration procedure or the operation of the machine. The updated software no longer tolerates a poor boom calibration and will lock the machine out if this condition is found.

Therefore Genie Z-135 MEWPs may be returned to service when upgraded to software version 3.06 or higher.
