No: NRS 287 Issue 3

Network Rail Safety Bulletin

Update: Return to Service – Genie Z-135 MEWPs

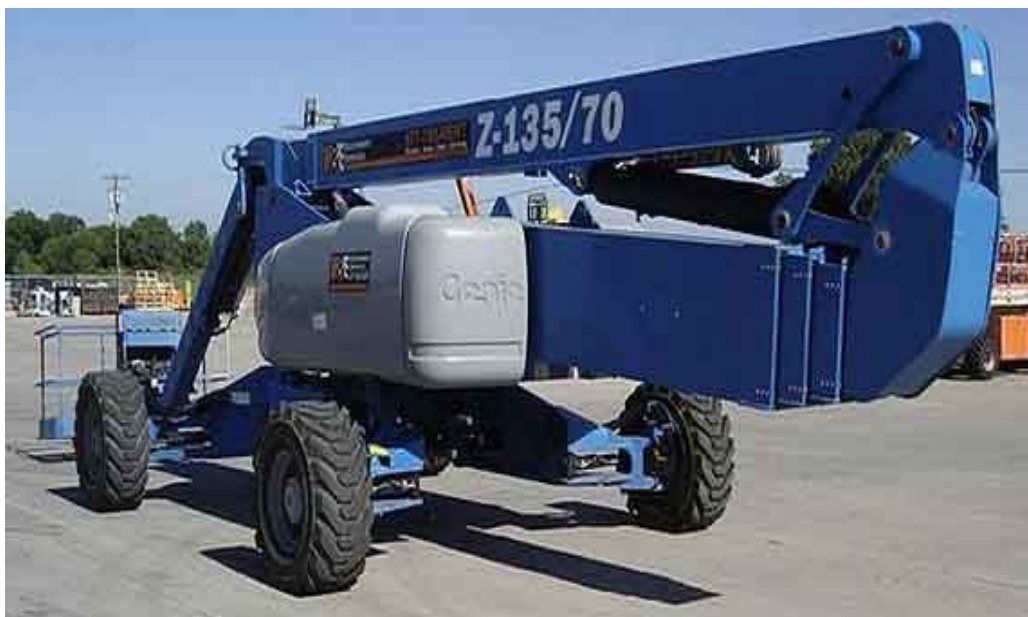
This incident was investigated by HSE who found that the root cause was an incorrectly calibrated secondary boom. HSE also found that, if followed correctly, the manufacturer's process for calibrating this machine is robust.

Genie have pro-actively updated the software for this machine. This updated software includes additional checks to the secondary lift calibration procedure without altering the physical calibration procedure or the operation of the machine. The updated software no longer tolerates a poor boom calibration and will lock the machine out if this condition is found.

Therefore Genie Z-135 MEWPs may be returned to service on the completion of the manufacturer's safety notice 130005 and before use on Network Rail managed Infrastructure upgrading to software version 3.06 or higher is a mandatory requirement.
