No: [NRS 293](#)

## Infrastructure Safety Bulletin

### Cracks On SRS 8T21 Work Basket Structure

For the attention of all users of SRS 8T21 Volvo FL6 Road Rail MEWP's

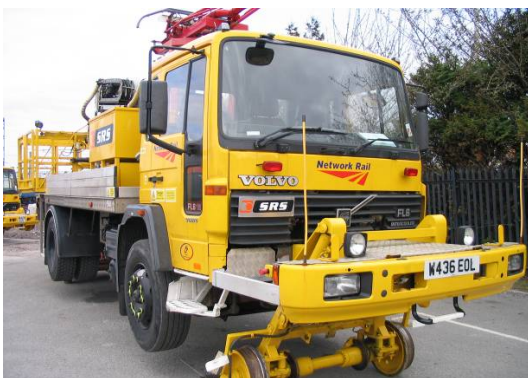
Example of affected vehicles  
SRS 8T21 Volvo FL6 Road Rail MEWP

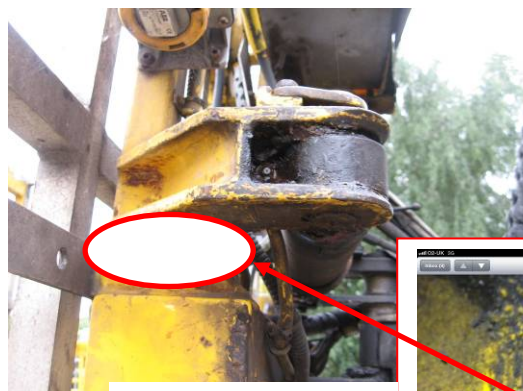
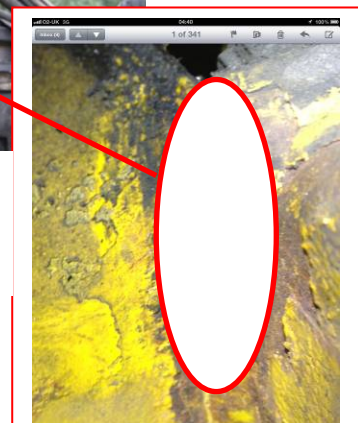
During planned electrification construction works over weekend 6-8 September 2013, cracks were found around the welded connection that forms the Work basket rotation mounting point.

The cracking has a direct effect on the structural integrity of the connection and the machines identified were withdrawn from service.

Complete failure of the mounting could have resulted in uncontrolled rotation of the work basket.

Example of location  
of cracking found  
around work basket  
rotate cylinder

The machines must be withdrawn from service with immediate effect and the following action taken

- Thorough and detailed inspection of the affected connection points using NDT
- Based on the outcome of the detailed inspection repairs should be carried out in line with approved weld procedures and processes by the appointed vehicle maintainer.
