No: **NRS 300**

Network Rail Safety Bulletin

On Track Machine Fitter Receives Electric Shock from OLE

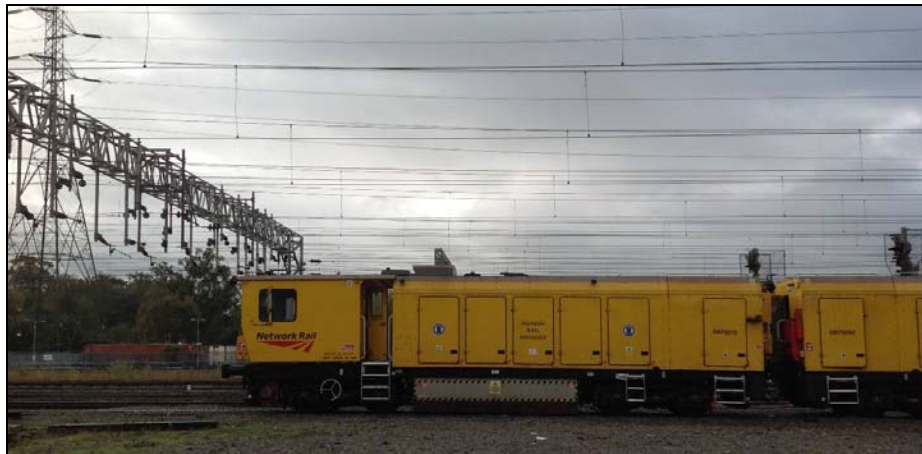
On Tuesday 5 November 2013 at 08:41, a serious accident occurred to an on track machine fitter at Stafford Up Arrival Sidings on LNW. It is understood that the on track machine fitter climbed onto the roof of the on track machine and received an electric shock from the OLE.

On track machine – rail grinder

Staff are reminded of the requirements of rule book GE/RT8000/HB16 – AC Electrified Lines, section 4.2:

You must never go above the cant rail or climb above the floor level of the driving cab, or climb on the roof or open upper deck of a vehicle, or on the steps giving access to the roof of any vehicle unless one of the following applies.

- You are on a line where there is no OLE above or adjacent to the vehicle.
- The OLE has been isolated and earthed as shown in Network Rail instructions and the COSS has been issued with an overhead line permit.
- The specific conditions in local instructions have been met.
- Local isolation is allowed and you are sure an isolation has been taken.
