No: IGS 301

## Network Rail Safety Bulletin

### Arthur Flury Single Rod Neutral Section Installations – Risk of uncontrolled release of Contact Wire tension

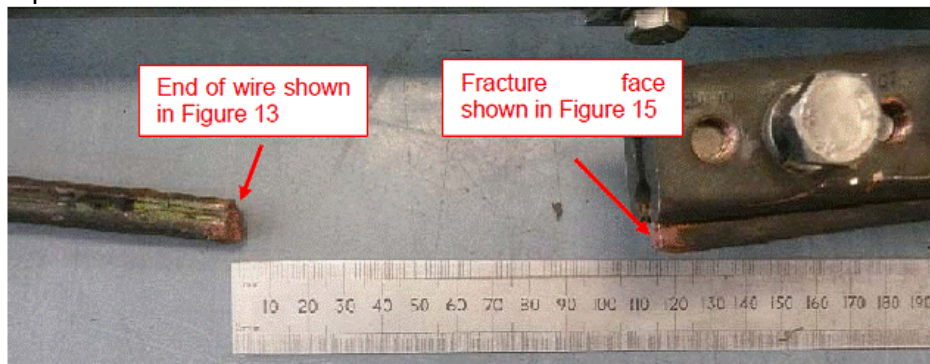
The primary cause of both dewirements has been determined to be a fatigue failure of the contact wire, with the initiation point being the top of the contact wire at the entry splice. Both neutral sections had been installed for approximately 2 years and were installed in 107mm<sup>2</sup> Hard Drawn Copper contact wire, with a line speed of 125mph.

Boroscope inspections of further neutral sections have found corrosion and signs of crack formation on other entry splices and LNE route are currently implementing a programme of mitigation measures to prevent further dewirements. The root cause of the fatigue failures is being investigated by LNE route, an independent investigator, the manufacturer and Energy Services.

Where any OLE works are being carried out at any Arthur Flury Single Rod Neutral Section location, a rig shall be installed across the Neutral Section assembly from contact wire to contact wire to mitigate against the risk of the wire parting and the uncontrolled release of tension.
