01/04/2014

No: NRS 318

Network Rail Safety Bulletin

TF25 Bogie Wheelset Lift Bracket Detachment

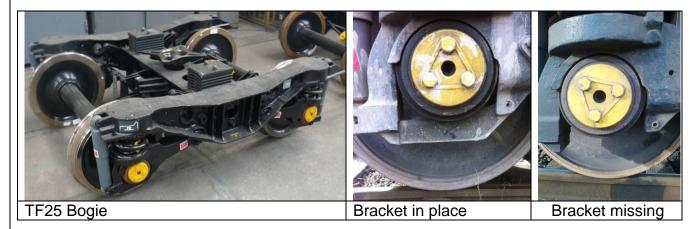
NIRS (numbers 2852 & 2966) were issued when vehicles had been found with wheelset lift brackets detached at the bolted end. After the issue of the NIRs a 100% fleet check was carried out of the bracket integrity on the Network Rail Fleet and all were found to be in place and correctly fastened.

An additional wagon belonging to Network Rail has now been found to have the wheelset lift bracket missing during VIBT examination at Westbury. This latest incident is therefore unexplained.

Further investigations are under way to establish the reason for failure and a new NIR 8250 has been issued.

Extra vigilance is required at pre departure/train preparation examination looking for any indication that the wheelset lift bracket is missing, has detached or partially detached at either end. Any defective vehicle must be removed from the train unless competent dispensation is given by the vehicle owner's Engineer, the maintainer or maintenance control.
