Safety Advice

Safety critical failures of link trolley brakes

Ref: NRA 15/06

Date of issue: 12/08/2015

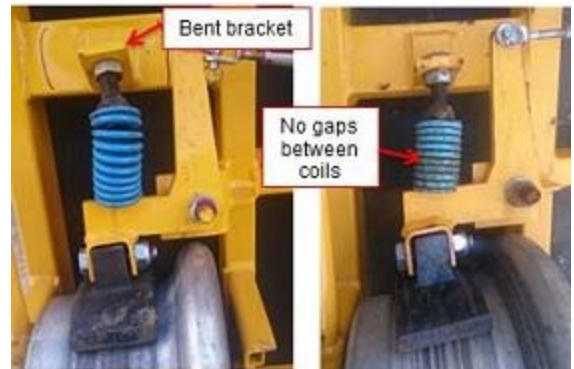
Link trolley failures

Inspection of the link trolley fleet at Northampton Bridge Street Depot found three out of eight units to have brake systems that had failed. Further investigation with Torrent Trackside identified evidence of other trolleys returned for maintenance with similar failures.

The right-angled bracket, which is welded to the frame and holds the brake spring in place, was bent away from the wheel. This reduces the brake force and increases the risk of runaway.

- **Link trolleys shall not be used on gradients steeper than 1:150 until further notice.**
- All link trolleys held by your organisation must be inspected, and units that display any of the following must be quarantined:
 - a) bent bracket holding the spring in place'; or
 - b) coil-bound springs (no gap between each coil).
- All link trolleys must undergo a pre-use check on each occasion of use. Any units with the signs of damage listed above must not be used and must be quarantined.
- Quarantined units must be labelled, removed from stores and reported to the maintainer.
- Users of link trolleys are reminded that the load must not be greater than one tonne. When trolleys are linked together the total load across all trolleys must not be greater than one tonne.
