Safety Bulletin

Rail lifting beam failure

Ref: NRB 15/11

Location: Borders Rail Project, Scotland

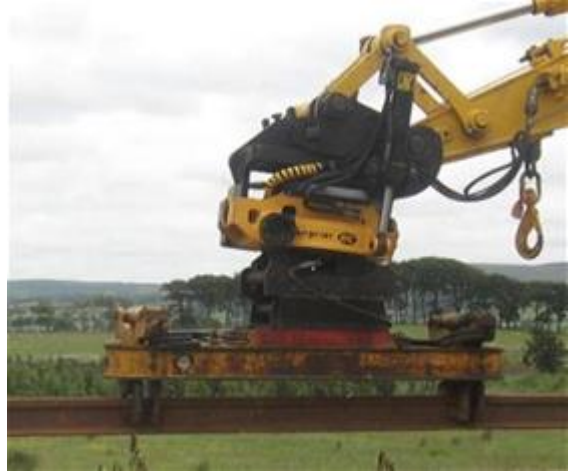
A rail beam tilt rotator

On 14 May 2015 a rail beam, being used to lift a 60ft section of rail, failed when the bolts securing the hitch adaptor plate to the main beam were stripped of their thread.

Reports indicate that the operator of the road rail excavator crane was attempting to lift a section of rail from the end, rather than in the centre as required by the Infrastructure Plant Manual NR/PLANT/0200/module P517.

It was possible to attempt the operation in this manner due to the beam being directly fitted to the tilt rotator, rather than the rotator being fitted to the dipper nose pin or via a flexible intermediate linkage onto an approved lifting point.

Lifting rail in this manner is not permitted as it will overload the lifting components and may cause complete failure as occurred in this instance.
