# Shared Learning from a Formal Investigation

Document ref: NRL 14\_01

Title: Derailment of a passenger train departing Liverpool Street station, 23 January 2013

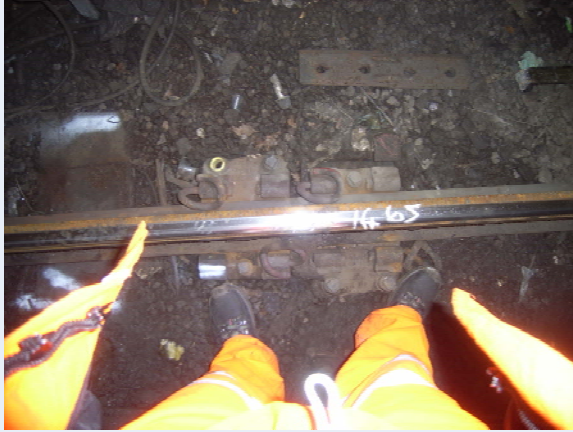
Chair shuffle marks
