Safety Advice

Robel Orbital Hand Tamper Failure - Remedial Action

Ref: NRA 15/09 Update 1

Date of issue: 19/11/2015

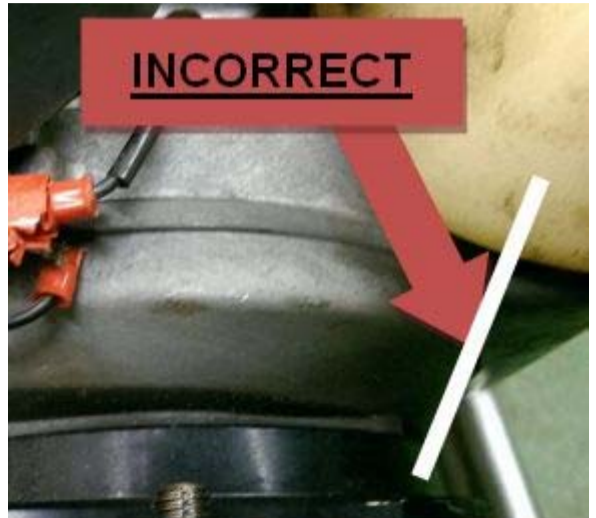
The **incorrect** fan housing can be identified by its sloping diagonal sides located on the base of the fan housing. This equipment must be removed from service, quarantined and returned to Torrent or Robel, dependent upon who owns the product.

- All 62.05 machines fitted with the incorrect fan housing, identified by its sloping diagonal sides located on the base of the fan housing, must not be used and must be removed from service, quarantined and returned to Torrent or Robel for rectification.
- All 62.05 machines fitted with the correct housing and all 62.05HY variants may return to service when used in accordance with standard operating procedures.
- If you are in doubt about whether the equipment is safe to use do not use it and seek assistance as below.

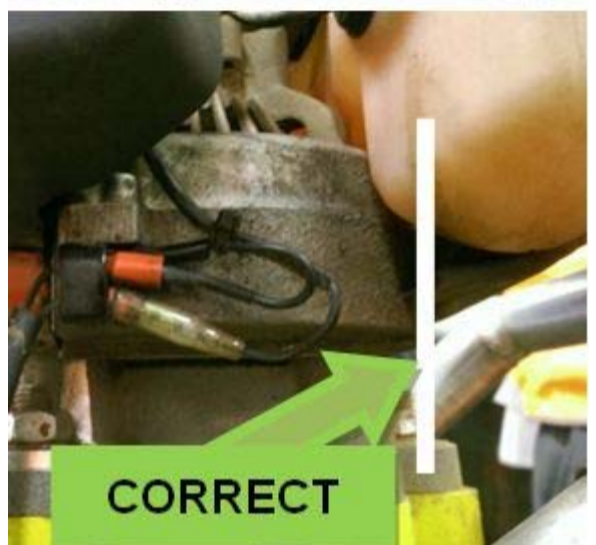
The **correct** fan housing can be identified by its vertical side extending to the base of the fan housing. Some of these variants are also manufactured in polished aluminium. These units may be returned to service and used in accordance with standard operational procedures and pre-use inspections.
