13th August 2013

No: NRS 291

Network Rail Safety Bulletin

WT Henley Cap and Pin Insulator Failure (Triple Dish Replacement)

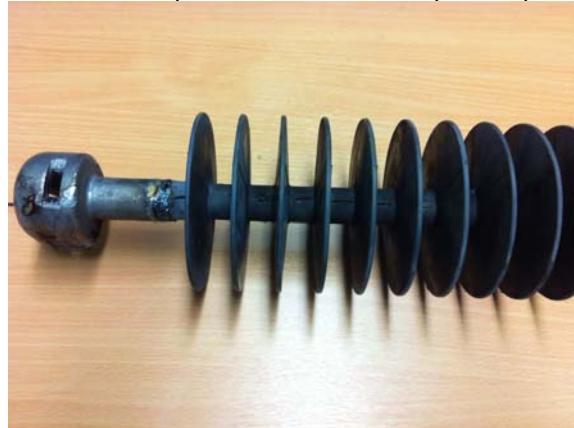
Following trippings on the North London Line, OLE staff found that a recently-installed WT Henley cap and pin type insulator had catastrophically failed due to flashover. Investigations have determined that the glass-fibre core of the insulator has failed due to torsional overload.

Subsequent enquiries have revealed that WT Henley insulators to PADS number 91/012574, Manufacturer Reference 56145-56 are not designed to withstand a high torsional load such as that imparted when turning the cap and pin end fittings under line tension, for example to re-orientate snap head pins.

1. WT Henley insulators to PADS number 91/012574, manufacturer reference 56145-56 must not be used in new installations for multiple tensioned conductors (e.g. contact & catenary tension combined), or where the conductor tension is greater than 11kN.
2. Where insulators of this type are already installed, a rig shall be installed across them to relieve line tension prior to performing any rotation of the "cap and pin".

Teams are reminded to lightly grease the ball and socket when installing new insulators from **ANY** manufacturer to minimise the friction of the bearing surfaces.
