Safety Bulletin

Spare and redundant lineside materials

Ref: NRB 15/14

Location: Portsmouth Main Line, Liss, Hampshire

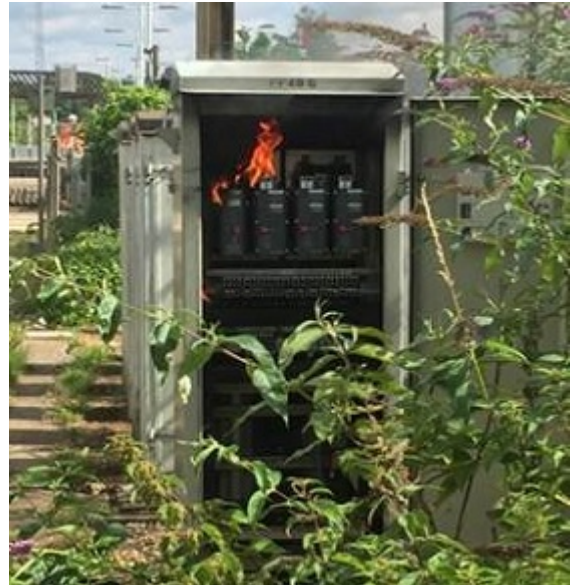
Initial investigation found that a 400 yard length of redundant conductor rail in the cess had moved and come into contact with the live conductor rail at one end and the hand rail of a location case at the other.

The hand rail and location case were earthed together and the current travelled into the signalling supply system.

The redundant conductor rail had not been secured to prevent movement in hot weather conditions.
