Safety Bulletin

Scour of bridge pier

Ref: NRB 16/01

Location: Lamington Viaduct, South Lanarkshire, Scotland

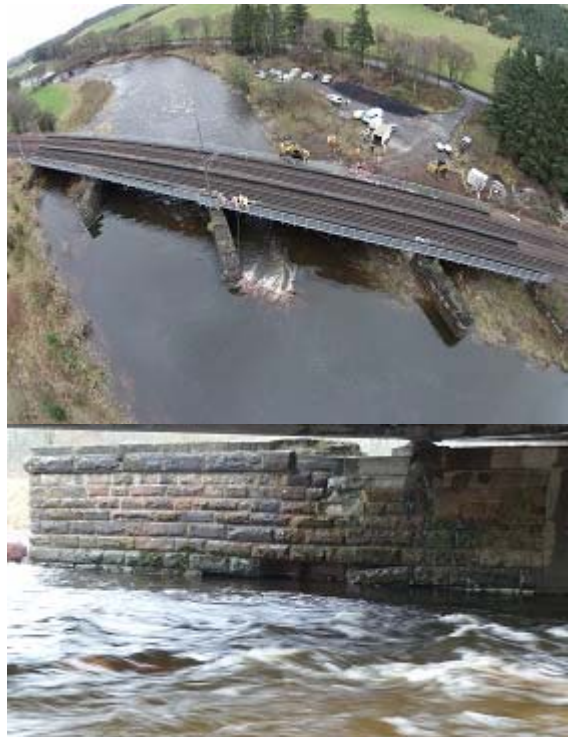
Subsequent examination of the central pier highlighted a missing 0.5 tonne sandstone block at the waterline with an approximately 2m vertical crack in the pier.

Following a detailed diver survey the pier was found to have been undermined over a length of 21m. The bottom seven courses of masonry had been scoured from the masonry section of the pier to a depth of 1.8m and a 1m deep void had occurred under the concrete section up to the full width of the pier. Surveys showed that the track had dropped by up to 150mm.
