SHARE WITH PAIN

Electrical Rail Shoes Ripped off by Dropped Rail in 6ft at Radlett

Tuesday 17th June 2014 at 07:58hrs

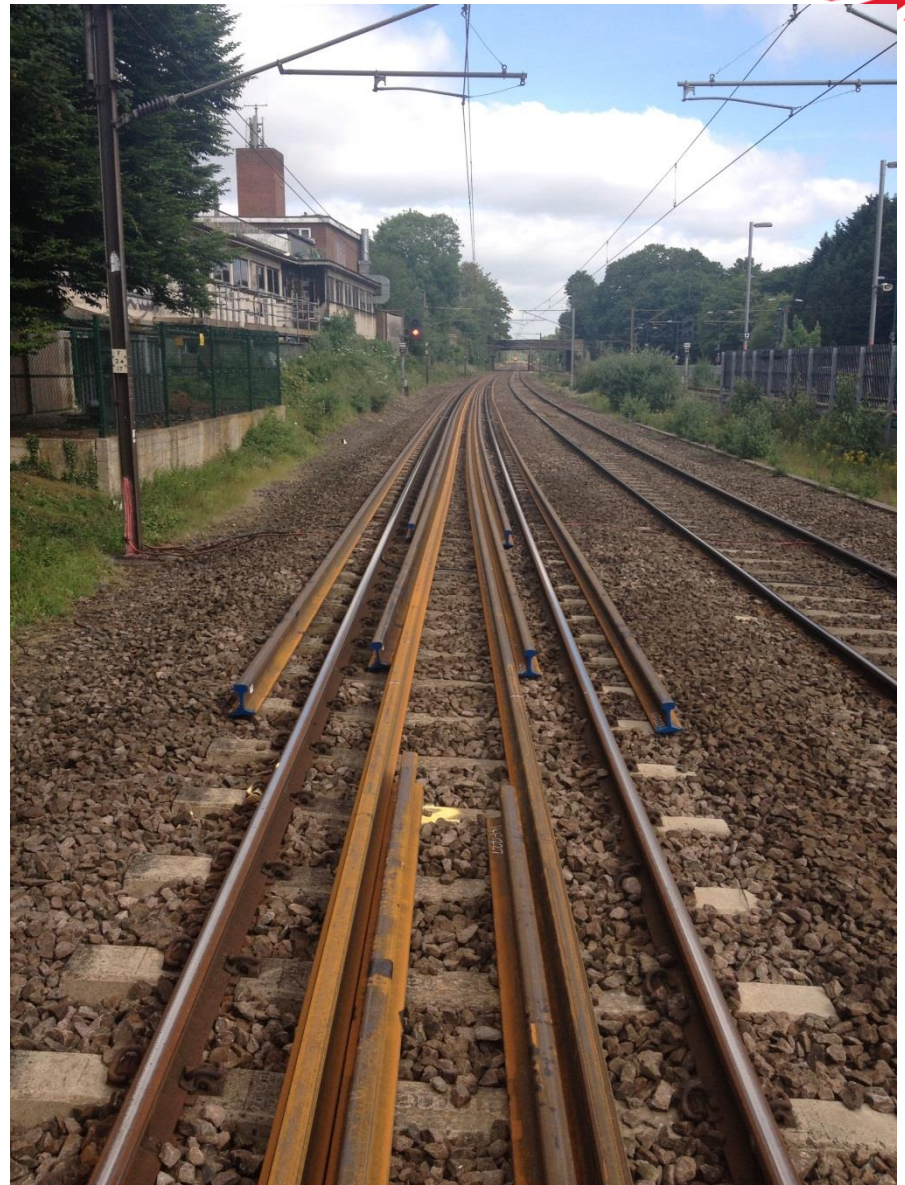
At 07:58hrs on Tues 17 Jun 14 an FCC train (2T99) struck rail in the 6ft on the Down Fast that had been dropped overnight.

This caused damage to the FCC train's 3rd rail conductor shoes and damaged an air hose.

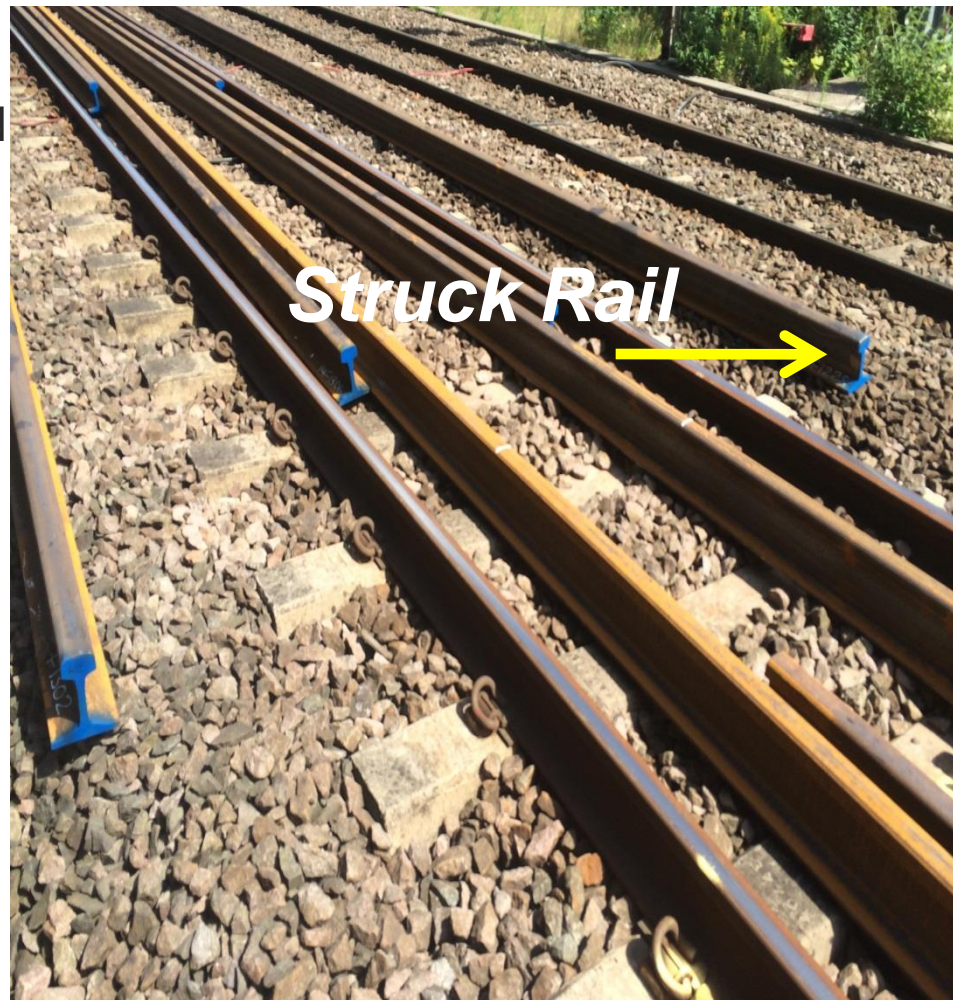
Incident occurred on the Down Fast, the train's 3rd rail conductor shoes and air hose hit CWR rail that had been dropped in the 6ft at Radlett Station.

Rail dropped in the 6ft was too high and too close to the running Edge of the Down Fast 6ft rail.

In addition rail in the 4ft was found to be close to the edge of the running rails in some areas.

This photo shows the 6ft rail after it had been moved.

- ▶ Rail deliveries should be in accordance with all relevant standards and processes, including rail management plans & work package plans. This is ever more pertinent in warm weather due to the risk of rail expansion.
- ▶ Rail deliveries should be in accordance with those agreed at the pre-delivery walkout with NSC. No changes to this should be accepted unless prior agreement and approval is sought and updated risk assessments and work package plans produced.
- ▶ This type of incident has occurred previously on the Midland Mainline (Steve Featherstone blog update in Mar 14 refers). Lessons learned relating to checks for third rail stock gauge clearance in none third rail areas and general good rail management practise need reiterating both internally & externally.
