Shared Learning from a Formal Investigation

Document ref: NRL 15/01

Title: Unidentified twist fault following an embankment slip at Stonegate For further information contact <u>Nick Solti</u>, Compliance & Assurance Advisor

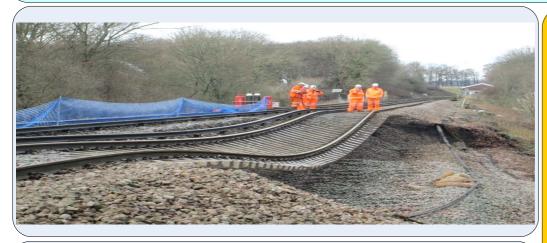
- Following weeks of unusually high and persistent rain a number of embankment slips occurred on the Kent route including the part of the Down Hastings Line at Stonegate on 09 February 2014. Both lines were blocked.

- On 10 February the RAM attended site and reported the track in a catastrophic state and hanging in the air (shown in the above photo).
- A Contractor was contacted to rebuild the embankment and the lines were reopened on 01 March with a TSR of 20mph on the up line and 5mph hour on the down.
