EVENT LEARNING

No.017

Incident Date / Time: 22nd July 2014 @ 15.00 hours
Location: Selby Swing Bridge
Works Taking Place / Incident Type: Rivet busting / Accident resulting in damaged tooth and mouth
Issued By: Safety and Sustainable Development Team
Project Name / Number: Selby Swing Bridge / 111740
For the attention of: All Scotland and North East

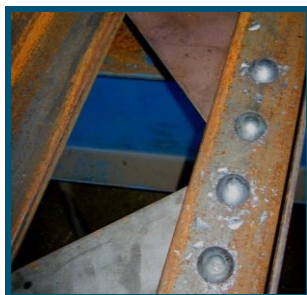
A rivet head sheared off, hit an adjacent steel stiffener and then ricocheted and struck an operative on the left side of his mouth causing a laceration and chipped tooth. The operative was using a rivet buster to remove a rivet head and working above eye level. Although the operative was wearing his visor correctly, the bottom section of his neck and face was exposed as he tilted his head to carry out the task and the rivet head bounced under the visor.

- There were no effective measures to prevent the rivet head ricocheting off adjacent steel work e.g. sandbags to deaden the impact of sheared rivet heads
- The length of the visor was not adequate to provide sufficient protection when used in this position e.g. a chin guard attached to the visor to protect neck and lower face.

- Where project works involves removing rivets, what measures will you consider to prevent uncontrolled movement of rivet heads as they are removed?
- What risks will be reflected in Work Package Plans and brought to awareness in Task Briefs?
- How will suitable PPE be identified and made available to prevent unwanted injury?
