Lessons Learnt from a Significant Event

Issue Number: TLP 005

Title: London Bridge Station Redevelopment, Scaffold Fitting Falling from Height

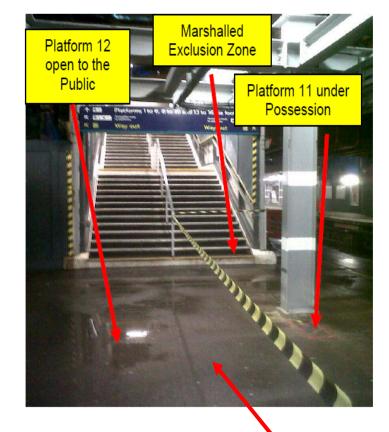
On the 7th March 2013, whilst deconstructing the protection deck above the platforms in London Bridge Station, a double swivel scaffold fitting fell onto the platform area. The work was taking place above platform 11 and there was an exclusion zone below. The exclusion zone covered platform 11 however when the fitting fell it bounced off the platform canopy and landed on platform 12 which was open to the public.

- The size of the exclusion zone was not sufficient for the activity and didn't cater for the potential of a deflection of material falling from above.
- A conscious decision was made to commence with the work before the adjacent Platform 12 was taken for the line block, which deviated from the agreed Work Package Plan and Task Briefing.
- None of the workers challenged the method of work or the exclusion zone as they had acknowledged the arrival of trains and stopped work until the platform below had cleared.

Scaffold clip landed on P12

- Exclusion zones should be planned in advance of the works
- The WPP and Task Brief should clearly define location and extent of exclusion zones
- Exclusion zones should be of adequate size in relation to the work area above, and capable of capturing the range of materials and equipment that could fall and bounce / deflect
- All exclusion zones should have adequate management arrangements in place including signage and barriers so that it is clear entry is prohibited.
