Date: 11th December 2014

Issued By: Thameslink Programme, HSEA Team, James Forbes House, 27 Great Suffolk Street, London SE1 0NS

Issue Number: TLP 024

Title: London Bridge – Excavator Arm struck Boat Skip (16th October 2014)

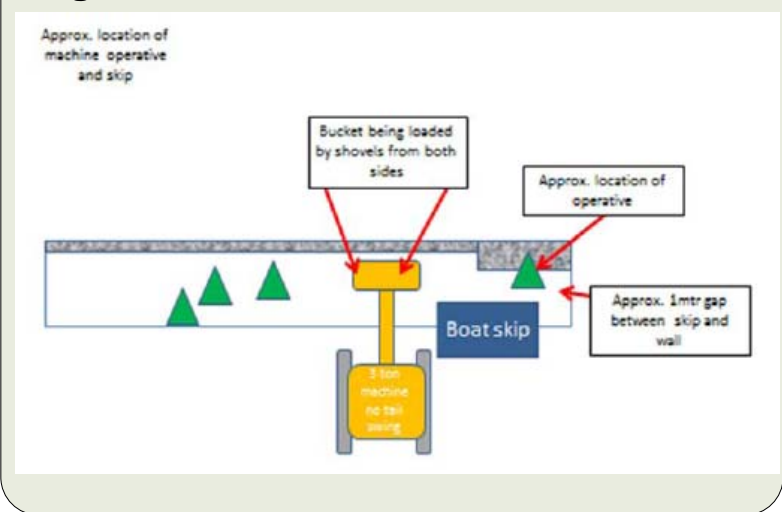
Diagram/Photo of event:

During the operation the excavator driver lifted and moved his bucket which then struck the boat skip, the skip jolted forward and struck an operatives leg.

- The driver failed to lift the bucket to a height which would clear the skip.
- The IP's position of safety was breached when the boat skip was hit by the excavator bucket - the configuration of the working environment was a contributory factor & specifically the position of the skip & its proximity to the wall
- The task was inadequately planned and change management was not properly addressed.
- The TBS was incomplete and did not cover the task adequately including positions of safety.
- The Supervisor for the works was undertaking two roles as he was also acting as banksman.

- A safety briefing took place for machine drivers, Banksman and Slinger / Signallers. Hazards and risks of working in close proximity to plant and machinery were covered, particular emphasis was made to blind spots where visual contact between driver and operative can in cases be challenging.

- Where a significant change in work method occurs the task must cease and re-planned. The Engineers will need to take full account of introducing heavy plant and machinery which will mean adapting and re-authorising by a Senior Engineer and briefing to Supervisors.

- A new system for pedestrian / operative detection is to be trialled at London Bridge. The Blaxtair is a visual & audible detection system which alerts the Driver of plant to anyone who enters or remains in a danger zone. The technology can differentiate between objects and people. Details can be found here <http://www.arcure.net/en>

- The issue of performing two different job roles at the same time will be shared throughout the project, emphasis will be made to stop works immediately should anyone be asked to perform dual roles in relation to safety.
