Date: 12th March 2015

Issued By: Thameslink Programme, HSEA Team, James Forbes House, 27 Great Suffolk Street, London SE1 0NS

Issue Number: TLP 029**Title:** London Bridge – Rebar Bending Machine (15th January 2015)

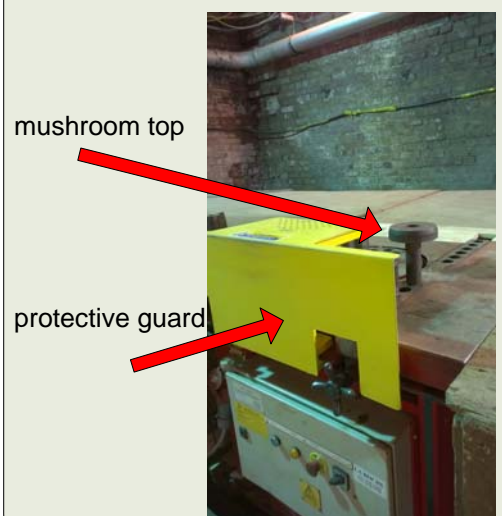
The immediate cause is that the rebar being bent in the bar bending machine rode up the roller and struck the IP.

The root cause of the accident is the design of the equipment. These deficiencies and other underlying causes, both significant and contributory include:

- Design – significant height difference between the 40mm dia. rebar and the bed or surface of the turntable.
- Design – the run-off side of the turntable is not level with the rebar as it leaves the former (roller).

- Design – the design of the small roller does not incorporate a means of captivation
- Design – guarding is not fitting to protect the operator from moving parts

Diagram/Photo: Bending machine after modifications

- The machine was taken out of service and modifications made by the manufacturer to provide a means of captivation as well as other aspects identified in the investigation and noted above.
- The working area was re-designed to permit only authorised persons to be near the operation of the machine and incorporated isolation switches.
- A standard operating procedure was written and used to train / brief users who are to be deemed 'authorised to use' the machine.
- PUWER requirements reviewed for the site.
- The site team were briefed on the event and findings / actions.
