Lessons Learnt: Local & Formal Investigations

Date: 20th June 2011

Issued By: Central HS&E: Investment Projects
Floor 13, 40 Melton Street, LONDON. NW1 2EE

Issue Number: 002: Erection of Scaffolding Structure within 500 mm from the live OLE on Birmingham Gateway Project – 23/11/2010

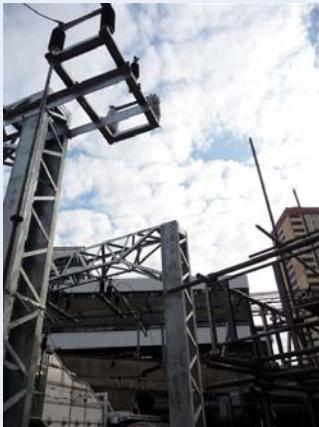
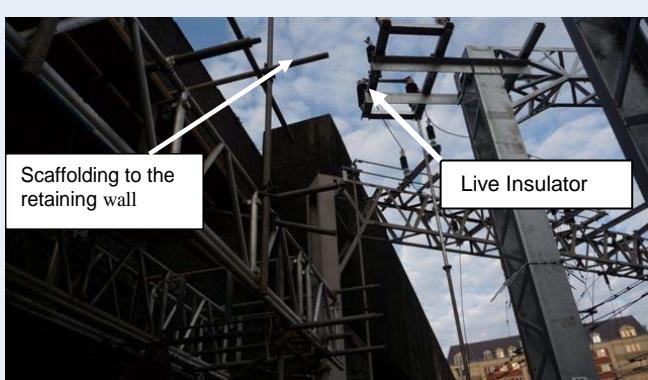
- An assumption was made by the Site Manager erecting the scaffolding that this newly erected OLE structure had not been commissioned.
- At the time of erection the OLE structure was isolated, but it had been commissioned and was due to be handed back into service at the end of the shift

- A passing NOM and Earthing Assistant on passing the scaffolding worksite immediately identified that the new section of scaffolding had been erected within 500 mm of this OLE structure.

- The impact of this slippage had not been communicated to the Temporary Works Designer, meaning vital information was missing, causing conflict between the scaffolding and the OLE works.

- An IDC had not been undertaken. If it had it is likely that the conflict described above would have been realised.

It is essential that inter disciplinary checks of designs take place, in order to establish that different design elements work together without causing danger to those involved in the buildability of the individual work packages.
