# Lessons Learnt from a Formal Investigation

## Document ref: NRRP 8

**Title:** Derailment of 6Z68 freight train near Castle Donington on 21<sup>st</sup> January 2013

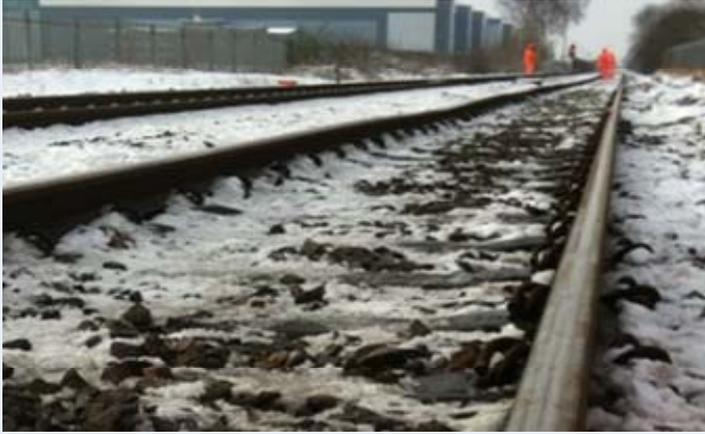
Photograph taken from Investigation Report

- On 21<sup>st</sup> January 2013, freight train 6Z68 travelling from Crewe to Toton derailed at the site.
- The principal causal factor to the derailment was the cyclic top fault.
