Lessons Learnt from a Formal Investigation

Document ref: NRRP 12

Title: Feeder Station Isolation Irregularity, Milton Fen, 23 August 2013

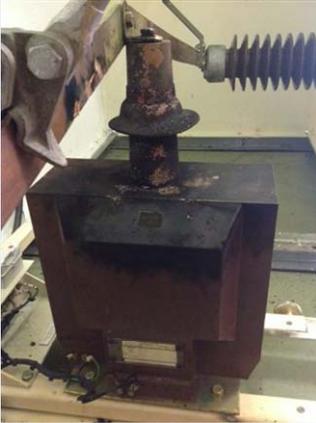
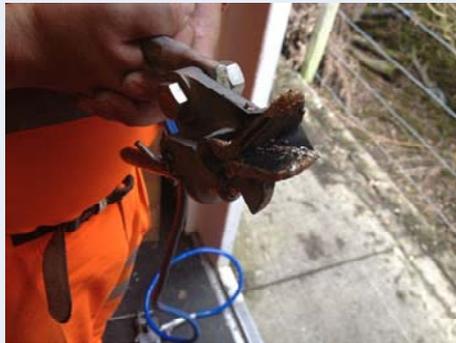
Voltage transformer and local earth showing electrical arc damage

- Once the Permit to Work had been issued, a Distribution Technician made preparations to disconnect one of the bushings from the “B” section busbar. In accordance with Distribution Work Instructions he used an additional local earth. As he brushed one end of the lead across the busbar an arc flash occurred as the busbar – still electrically live at 25kV– was shorted to earth.
