# Lessons Learnt from a Formal Investigation

## Document ref: NRRP13

**Title:** Lookout struck and fatally injured by train at Newark Northgate on 22 January 2014

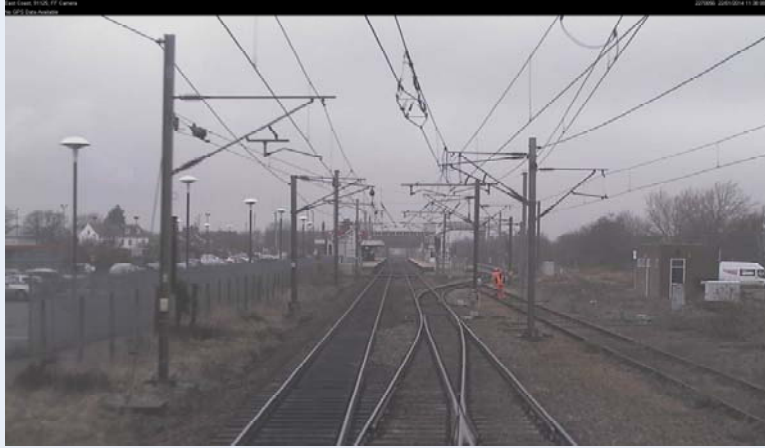
- A short time later the 10.08 London Kings Cross to Newark Northgate passenger service was signalled across from the down fast onto the up fast and into the passenger loop. The driver saw the lookout and rail tester and sounded his horn. They both acknowledged the warning and moved immediately to the position of safety.

- At 11.35, just as the train entered the crossover from the down to up fast, the lookout, who was standing behind the rail tester, turned around and started to walk back towards where he had previously been stood acting as lookout.

- His path took him directly across the passage of the train and although the driver sounded a further warning, which the lookout acknowledged, he continued to walk directly in front of the train, seemingly oblivious to its proximity.
