Lessons Learnt from a Formal Investigation

Document ref: **NRRP 10**

Title: Displacement of Pandrol clips at Mansfield Woodhouse on 10/11 June 2012

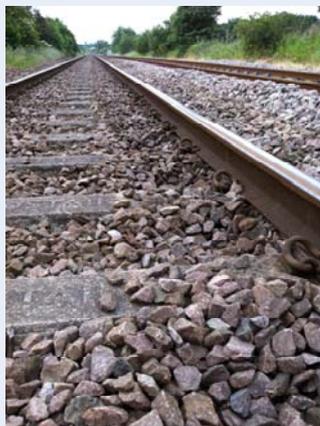
Left: ballast profile resulting from tamping at speed

- Displacement of the Pandrol clips was discovered by an individual placing protection for a possession six days later.
- The immediate cause was that the speed at which tamper 75409 was operated was above the speed at which it had been designed to operate. The increase in operating speed reduced the time available in the tamping cycle for the tamping bank to withdraw from around each sleeper. At the time in the cycle that the tamper came to move forward to the next sleeper, the tamping bank had not withdrawn sufficiently to clear the Pandrol clips.

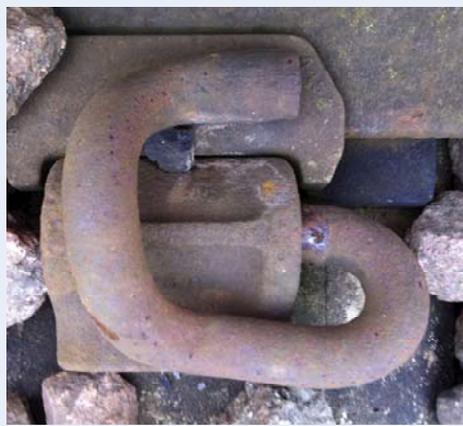
Right: partially displaced pandrol clip

- During the course of the shift, part of the tamper intermittently came in to contact with the Pandrol clips that retain the rail in position on a sleeper. This contact occurred as the tamper moved forward from sleeper to sleeper without its tamping banks fully retracted.

- 465 Pandrol clips were hit by the tamper; 140 of these were fully displaced from their housings. While the pattern of displacement was random, at one location ten consecutive clips were fully displaced.
