EVENT LEARNING

Works Taking Place / Incident Type: Asset damage during construction of Location Cabinet Bases

Project Name / Number: IEP Merchant Park / 131267

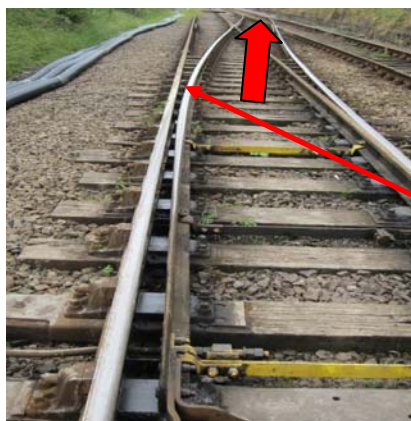
Direction of RRV Travel
(Note Switches were set in opposite direction to shown in photo)

The construction of Location Cabinet Bases required materials to be transported from the site access to the area of work using an RRV. Upon completion of the work, the Signaller reported that a track circuit failure was evident. Following investigation, damage to a Track Circuit Interrupter (TCI) was observed.

The TCI is located on the entry into the SPAD Overshoot track and protects the single line at this location.

- Whilst a pre-work site survey was carried out, the site team were unaware of the TCI or the function it provides (specifically located at SPAD Overshoots and on Trap Points).
- The RRV being used was a 'low rail' type where the RRV tyres contact the head of the rail. It is thought that ballast lodged within the tyre tread came into contact with the TCI.

- Do you have a project where RRVs are used in the vicinity of SPAD Overshoots and Trap Points?
- Will your project / site surveys detect the presence of TCI's on *your* sites?
- Where TCI's are present, how is the requirement for 'high rail' type RRVs assessed and managed?
- Alternatively, seeking S&T expertise for disconnection, removal and reconnection of the TCI may be required.
