Shared Learning

Key learning following a serious incident

Embankment failure caused by construction activity affects safety of the line

Ref: NRL 15/03

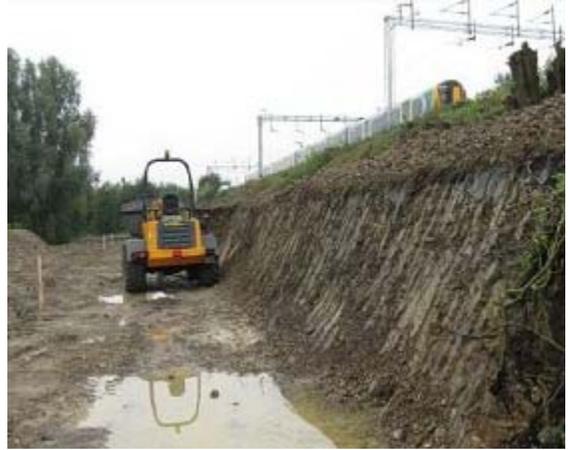
Toe of embankment removed without support

The track had dipped by up to 26mm over a distance of some 25m. The movement was directly above newly installed stone intended to improve the sliding resistance of the embankment. The design required progressive removal of embankment material in six metre sections, replacing it once the stone had been installed.

Extensive excavation of the embankment was left unsupported for a period of seven days.

However 130 linear metres of material at the toe of the embankment was removed over four days in an attempt to progress the works and reduce plant and equipment costs.

Space constraints in the restricted site led to removing significantly more material from the toe of the embankment to facilitate vehicle movements.

- Principal Contractors and Designers must reach a clear understanding on the preparatory works and sequencing necessary to achieve safe and efficient construction.
- Robust track monitoring must be in place before work starts that might affect the operation of trains.
- Assurance regimes must be in place from the start of site work to check that it is compliant with the design.
- Site safety documentation must be approved by all parties prior to the start of site work.
